4. RESERVE COMPONENT DETAIL

Exterior Building Elements

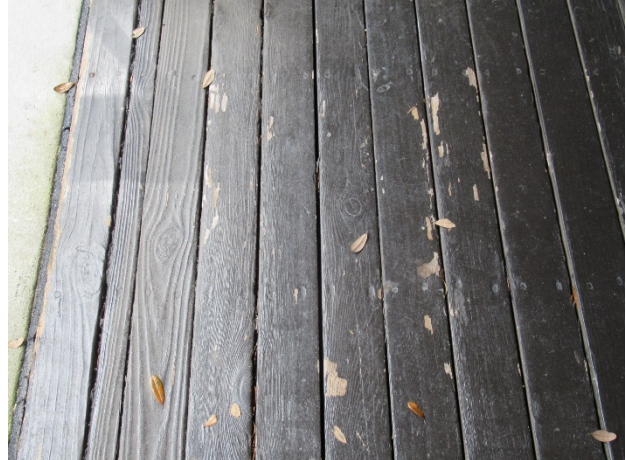
Condition: Good to fair overall condition with finish deterioration evident

Wood deck with paint finish deterioration

Expenditure Detail Notes: Expenditure timing and costs are depicted in the **Reserve Expenditures** table in Section 3. Our cost for interim repairs includes replacement of the deck boards and partial replacement of deteriorated wood components. Proper maintenance should include the following activities funded through the operating budget:

- Securing of loose fasteners and replacement of deteriorated fasteners
- Replacement of deteriorated wood components
- Power washing with an algaecide and application of a sealer/stain

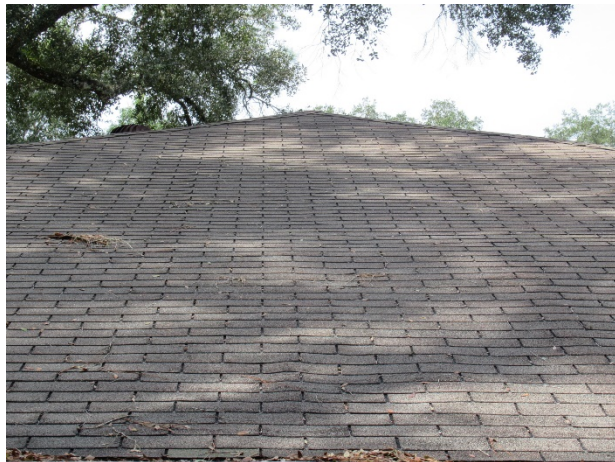
Condition: Good to fair overall with warped shingles and past repairs evident from our visual inspection from the ground. Management and the Board do not report a history of leaks.

Clubhouse roof overview – note warped shingles

Expenditure Detail Notes: Expenditure timing and costs are depicted in the **Reserve Expenditures** table in Section 3. We base our cost on replacement with architectural dimensional shingles.

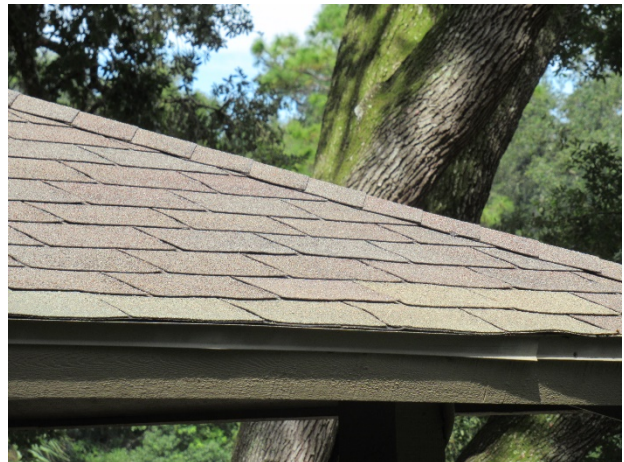
Clubhouse roof with past repair evident

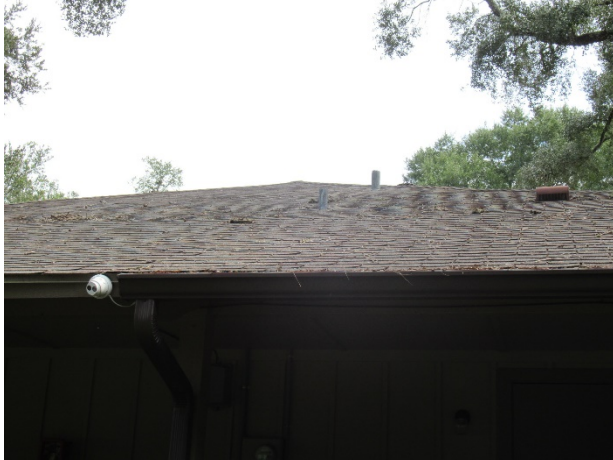
Clubhouse roof with warped shingles

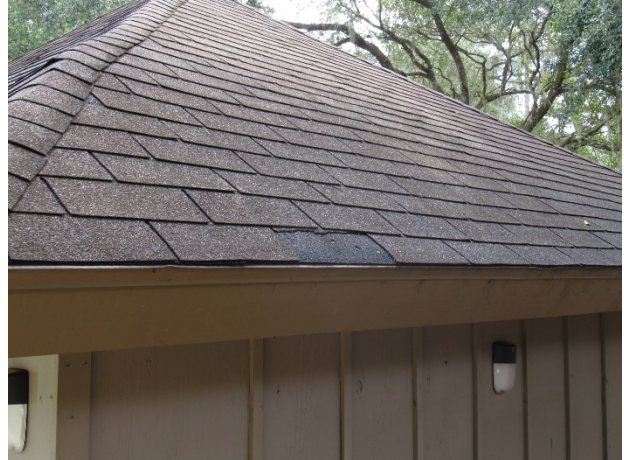
Maintenance shed roof with missing shingle

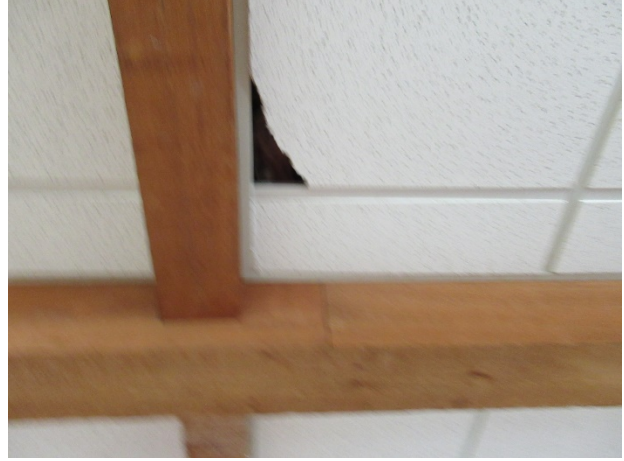
Condition: Good overall with an isolated damaged tile

Acoustical ceiling tile with damage

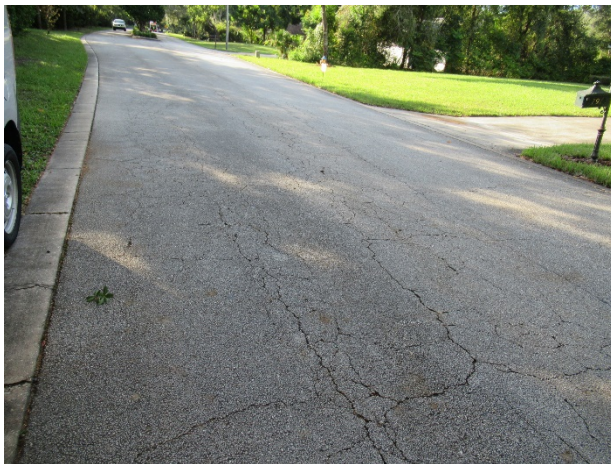
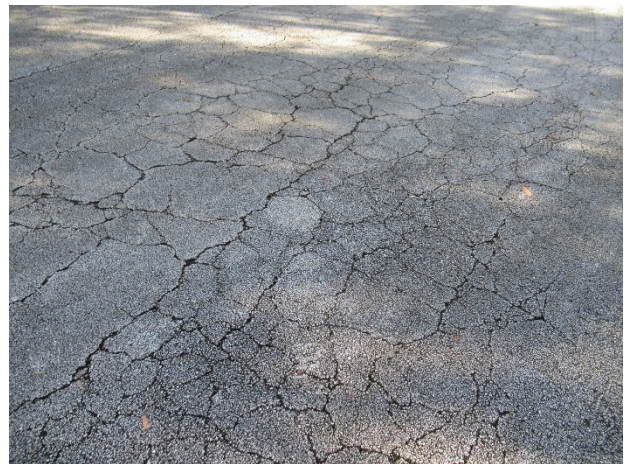
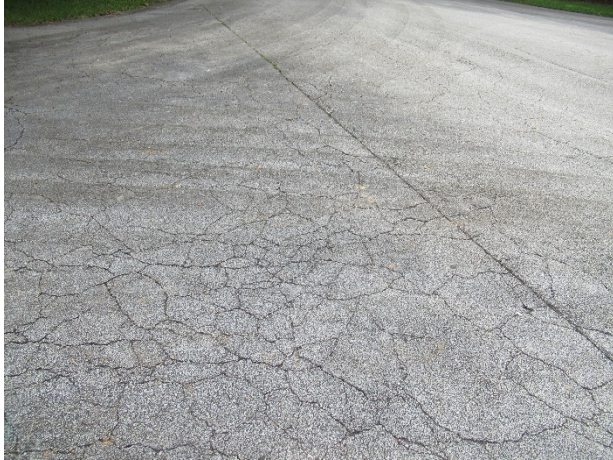
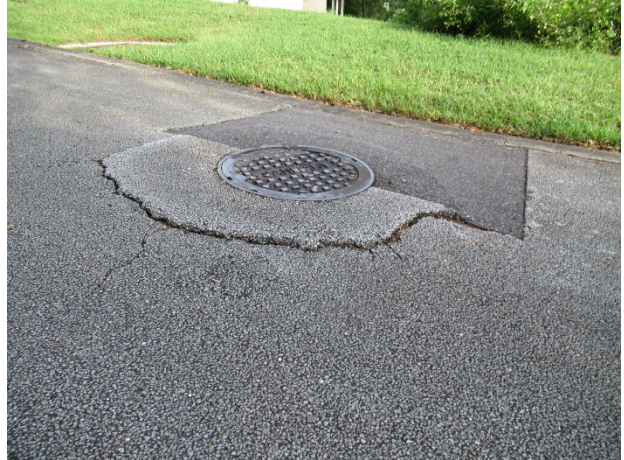
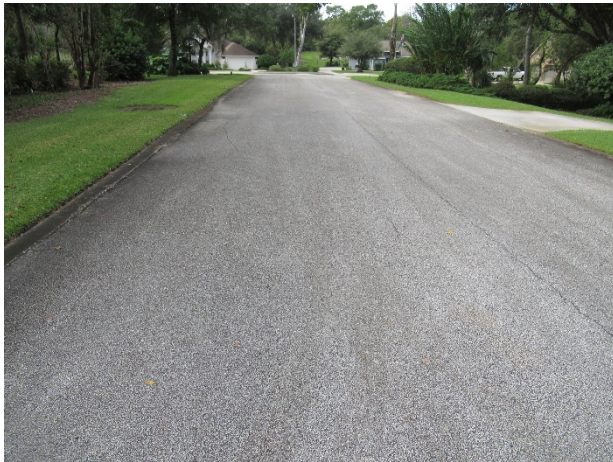
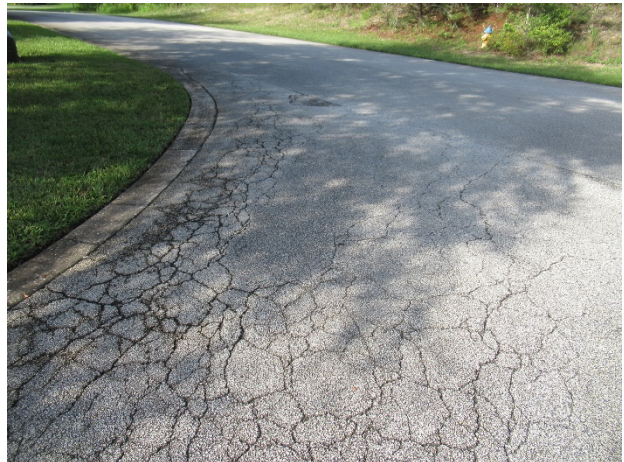
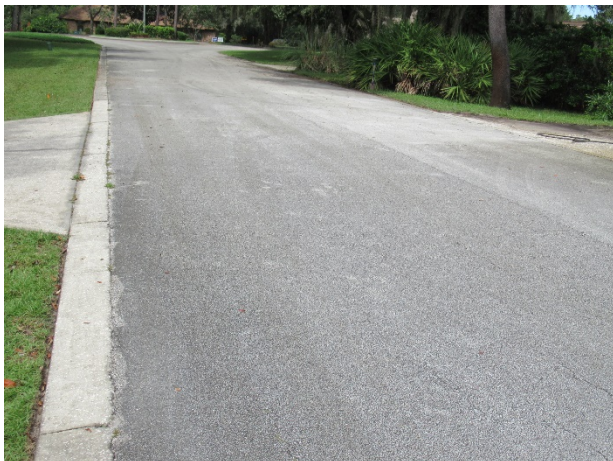
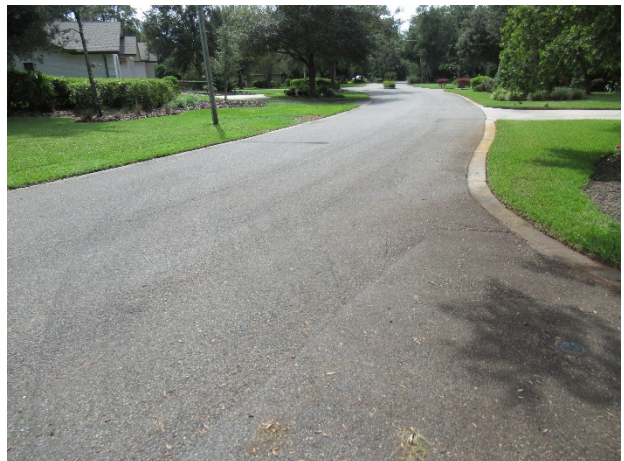
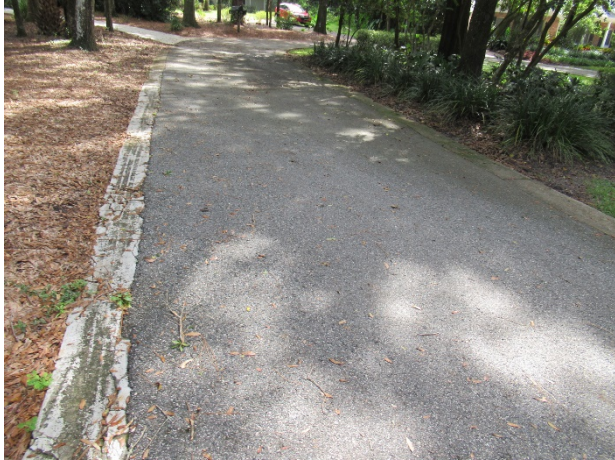
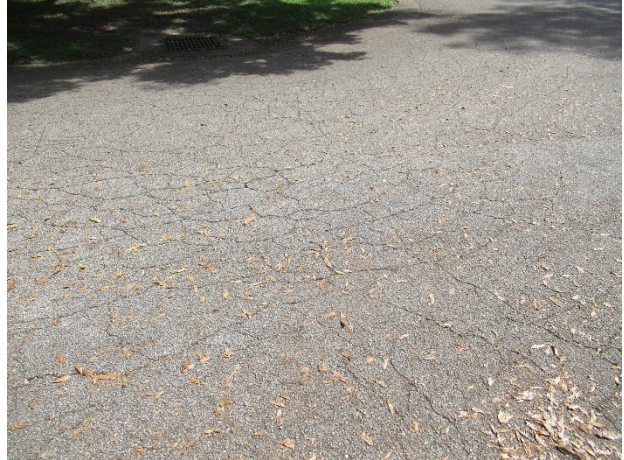
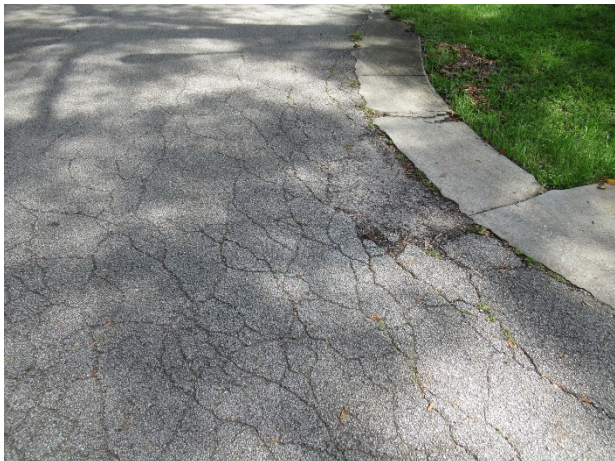
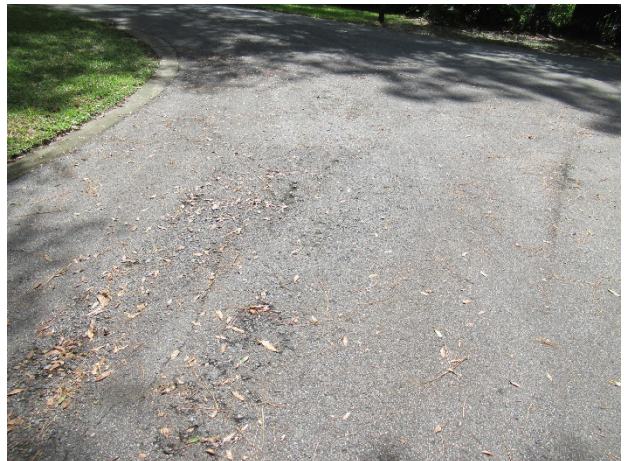
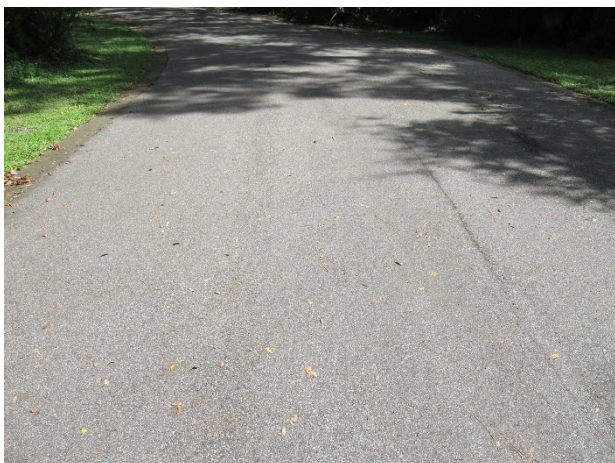
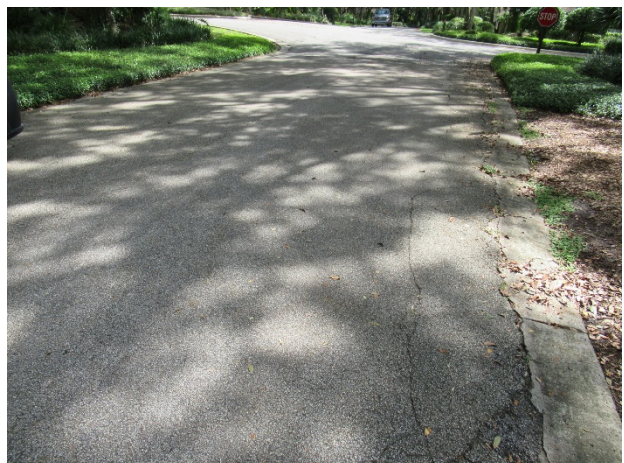
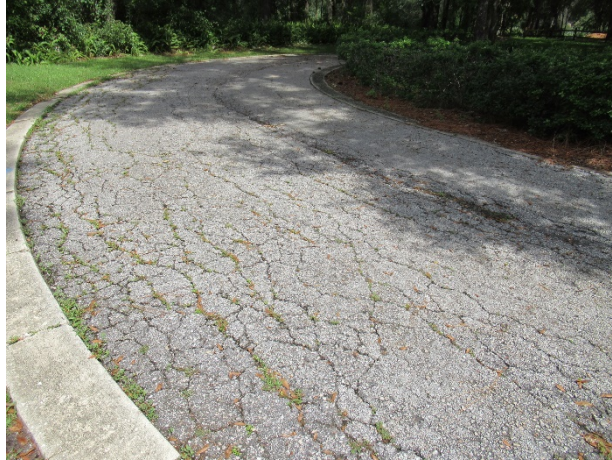
Condition: Fair overall with areas of extensive fatigue cracks

followed by the application of two or more new lifts of asphalt. We recommend mill and overlayment on asphalt pavement that exhibits normal deterioration and wear. We recommend total replacement of asphalt pavement that exhibits severe deterioration, inadequate drainage, pavement that has been overlaid multiple times in the past or where the configuration makes overlayment not possible. Based on the apparent visual condition and configuration of the asphalt pavement, we recommend the mill and overlay method of repaving at Trails West.

Expenditure Detail Notes: Expenditure timing and costs are depicted in the **Reserve Expenditures** table in Section 3. Our cost for milling and overlayment includes area patching of up to ten percent (10%).

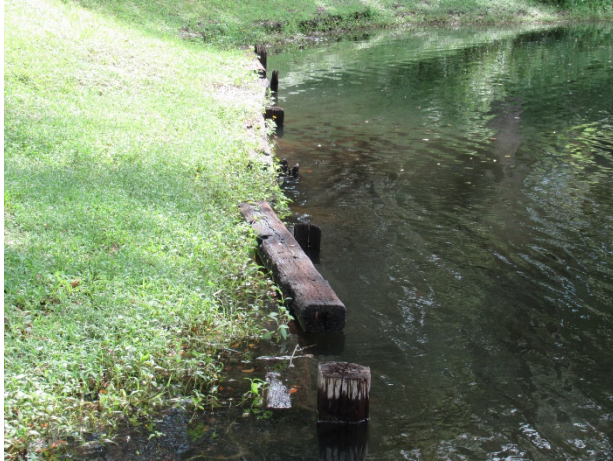
Condition: Poor. The bulkhead has failed.

South pond bulkhead – this retaining wall has failed

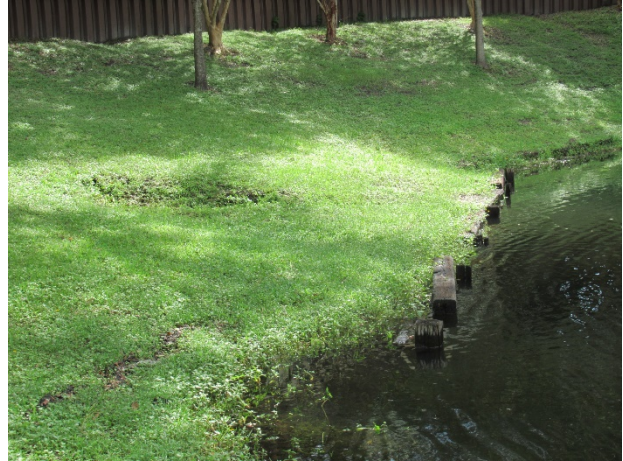
South pond bulkhead – soil erosion is evident in the area behind the wall

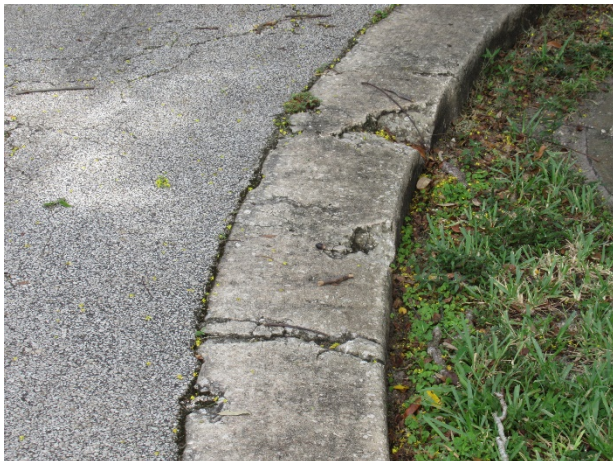
Condition: Good to fair overall with areas of cracks and deterioration

Ribbon curb with cracks – Waters Edge Trail

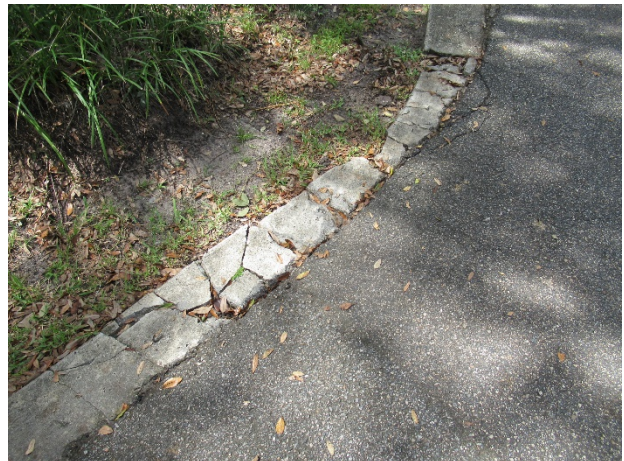
Ribbon curb with severe deterioration – Woodridge Trail

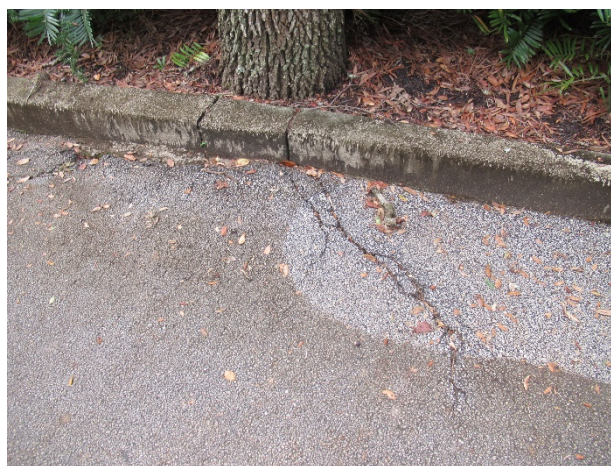
Standard curb with cracks and displacement near tree – Black Willow Trail
