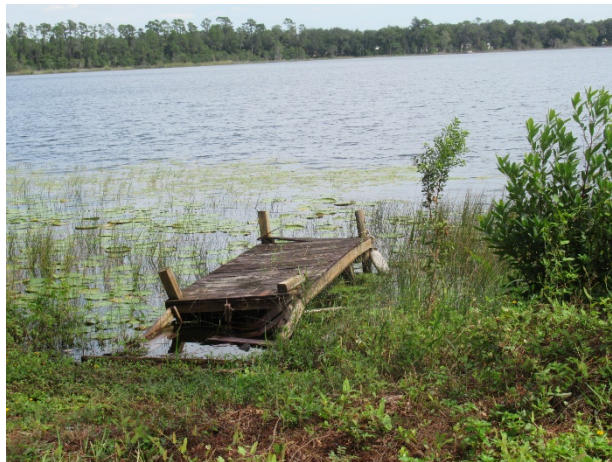
History: The original dock was destroyed during recent storms.

Remains of original dock

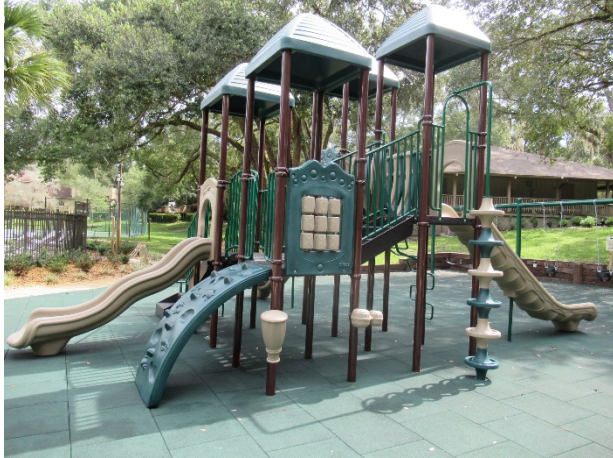
Condition: Good overall

Playground equipment overview

Component Detail Notes: Safety is the major purpose for maintaining playground equipment. We recommend an annual inspection of the playground equipment to identify and repair as normal maintenance loose connections and fasteners or damaged elements. We suggest the Association learn more about the specific requirements of playground equipment at PlaygroundSafety.org. We recommend the use of a specialist for the design or replacement of the playground equipment environment.

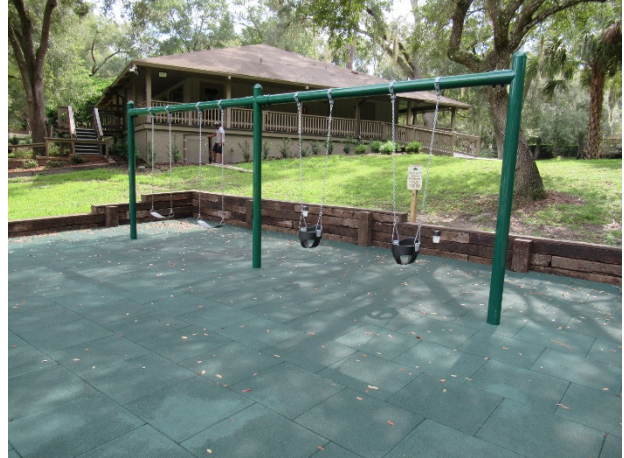
Swing set overview

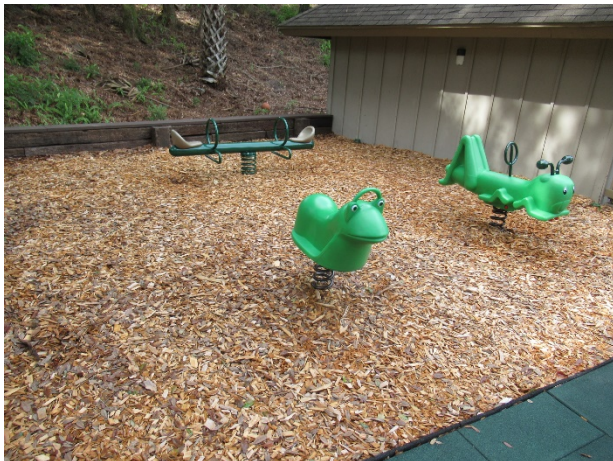
Spring riders overview

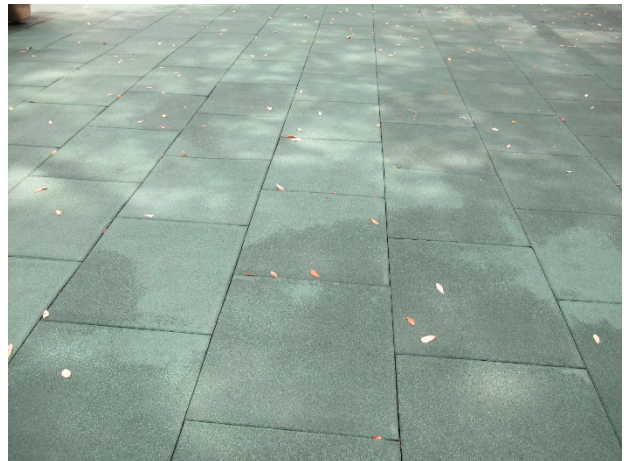
Safety surface overview

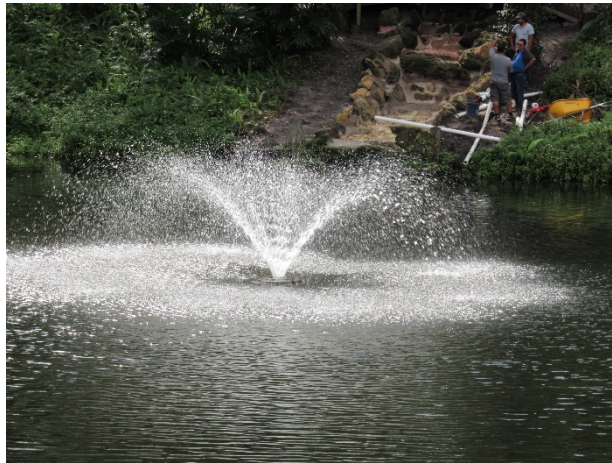
Condition: Reported satisfactory

Pond Aerator overview

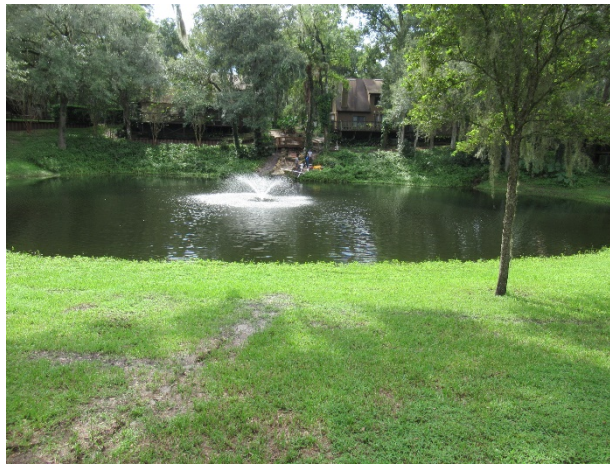
Condition: Management informs us that the liner is in need of replacement

Pond with liner overview

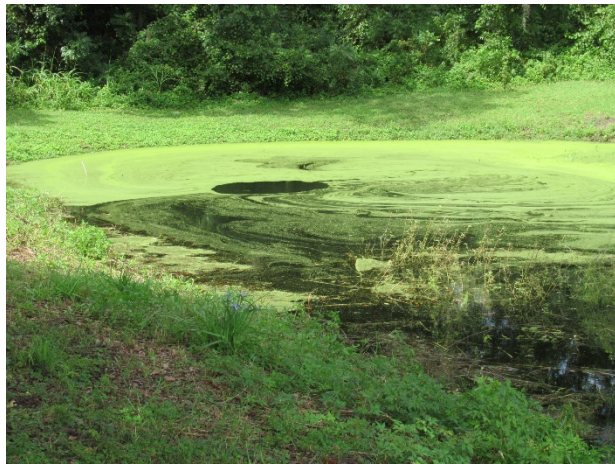
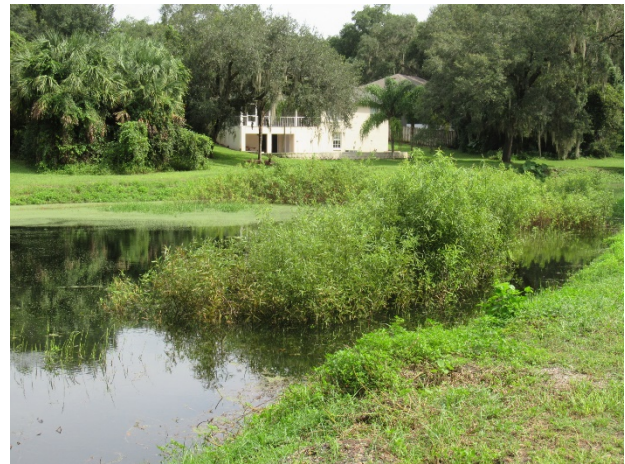
Condition: The pond exhibits extensive algae growth

Pond with algae growth

Useful Life: Based on the visual condition, adjacent deciduous trees and visibly apparent erosion, we recommend the Association anticipate the need to remove pond sediment every 30 years.

Expenditure Detail Notes: Expenditure timing and costs are depicted in the **Reserve Expenditures** table in Section 3. For reserve budgeting purposes, we estimate the need to remove an average depth of one yard from approximately fifty (50%) of the surface area. However, the actual volume of material to remove may vary dependent upon an invasive analysis at the time of removal. A visual inspection of a body of water cannot reveal the amount of accumulated silt. This is especially true on larger bodies of water. It is therefore inaccurate to assume an entire body of water will require sediment removal. It is more cost effective to spot remove in areas of intense silt accumulation as noted.

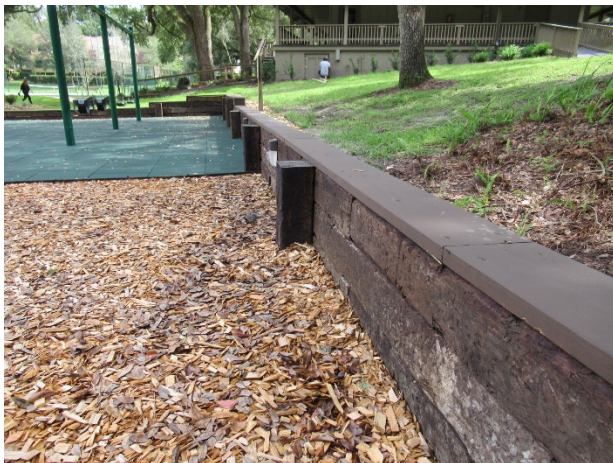
Playground retaining wall overview

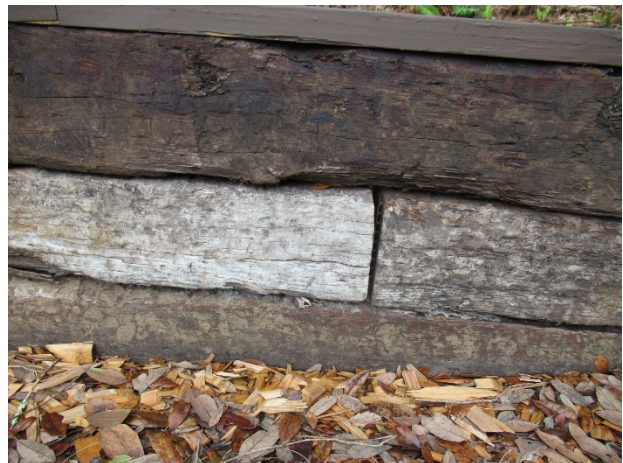
Condition: Fair Condition with weathered timber evident

Playground retaining wall with weathered timber

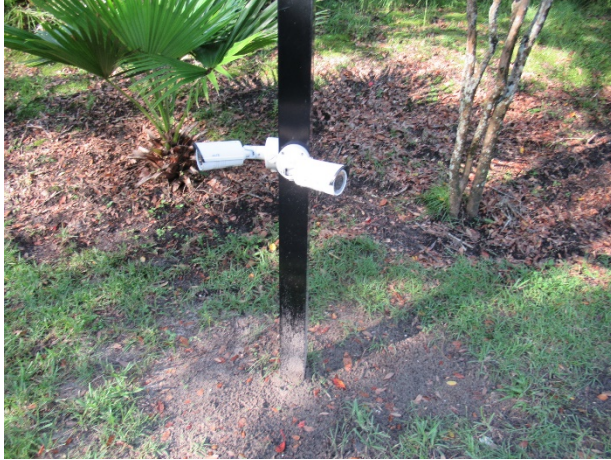
Security cameras at north entrance

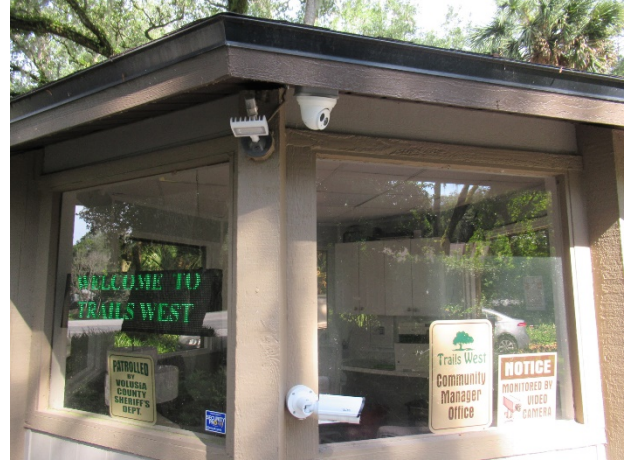
Security cameras at west entrance

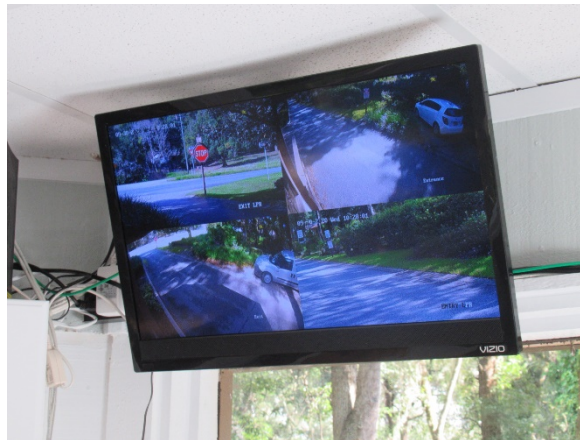
Monitor at office

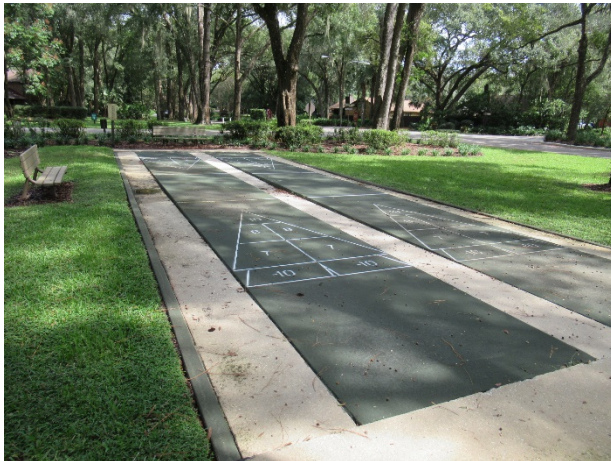
Shuffleboard courts overview

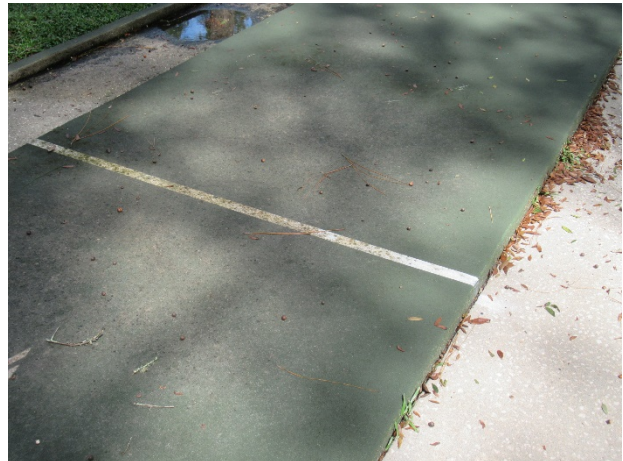
Condition: Good to fair overall with stains to the playing surface

Shuffleboard court with stains

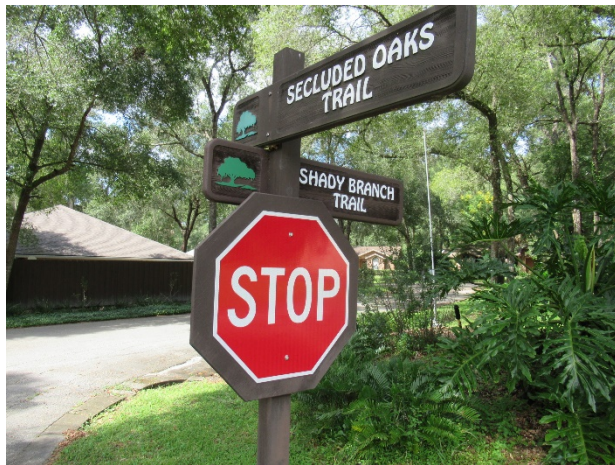
Condition: Fair overall with areas of finish deterioration and wood rot

Street and traffic sign overview

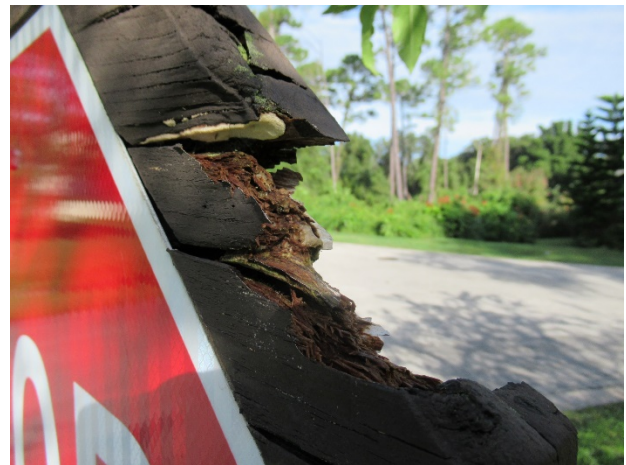
Street and traffic sign with wood rot

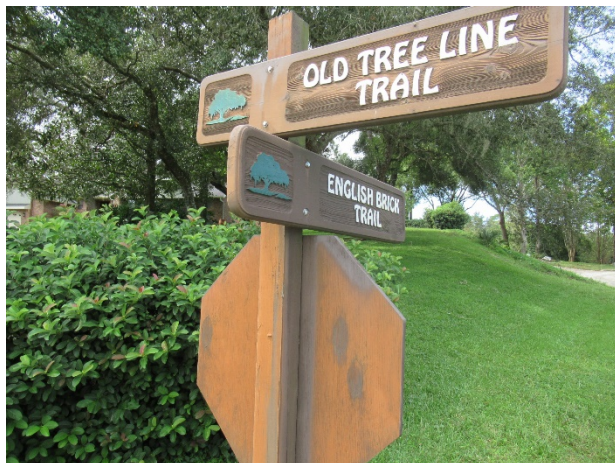
Street and traffic sign with finish deterioration

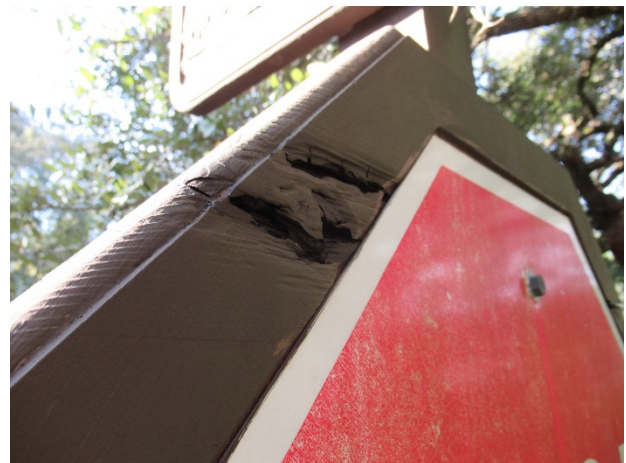
Street and traffic sign with wood rot and finish deterioration

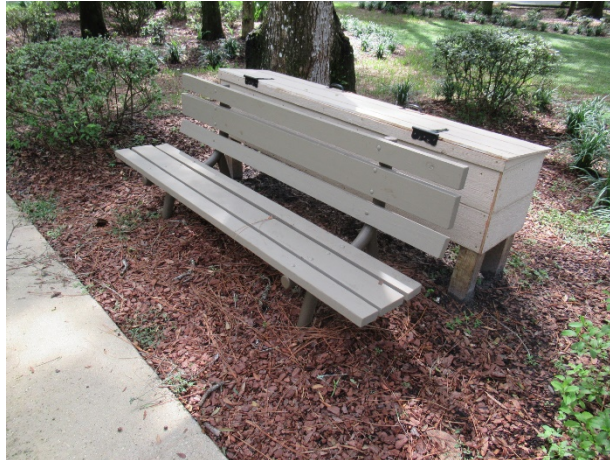
Condition: Good to fair overall

Bench at shuffleboard court

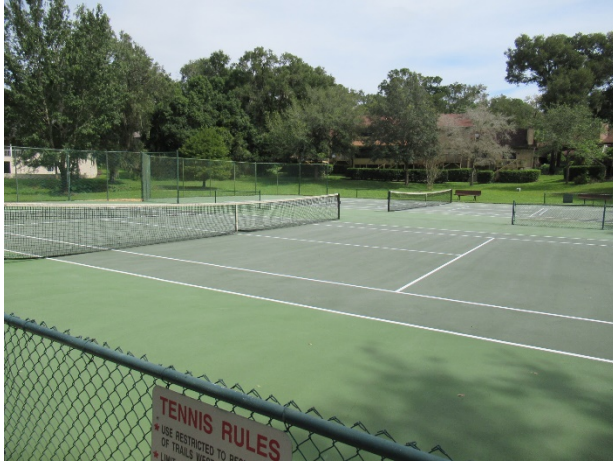
Tennis court overview

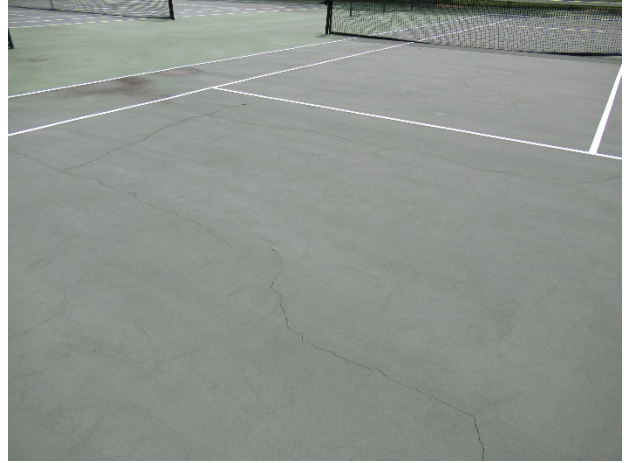
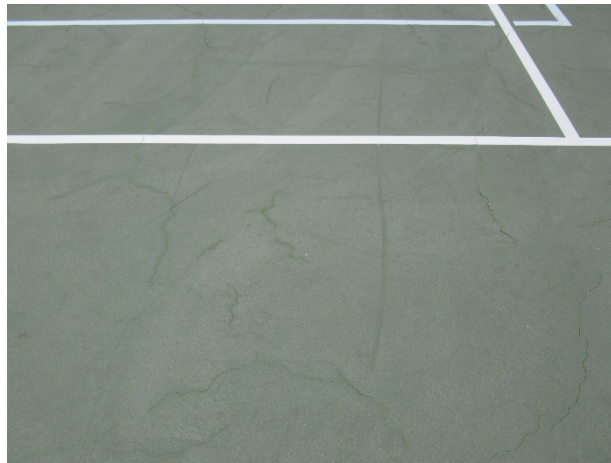
Condition: Good to fair overall with color fade evident

Tennis court with color fade evident

Component Detail Notes: Prior to the application of the color coat, the Association should require the contractor to rout and fill all cracks with hot emulsion. This deters water infiltration and further deterioration of the asphalt playing surface.

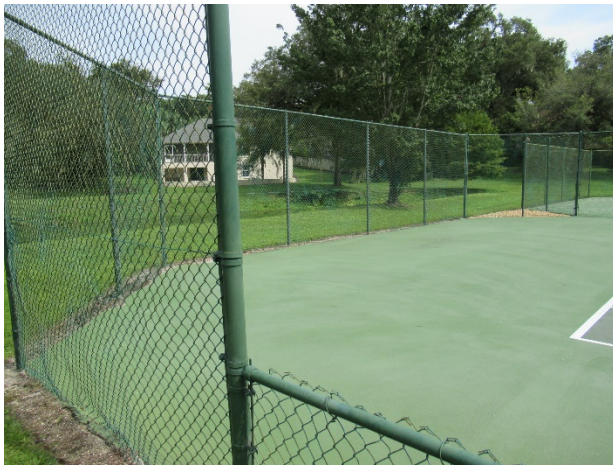
Condition: Fair overall with minor damage and finish deterioration evident

Tennis court fence overview

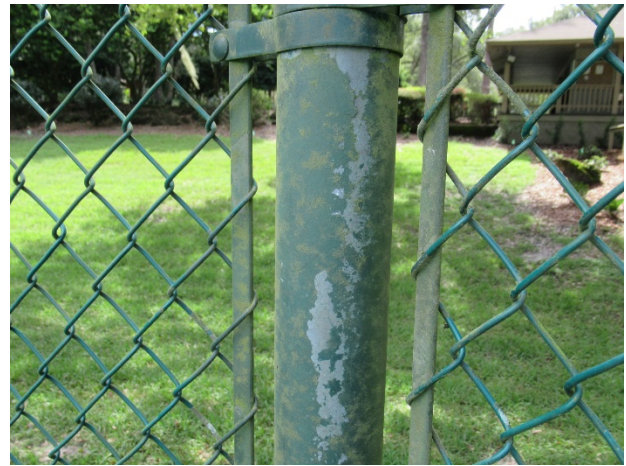
Tennis court fence with stains and finish deterioration

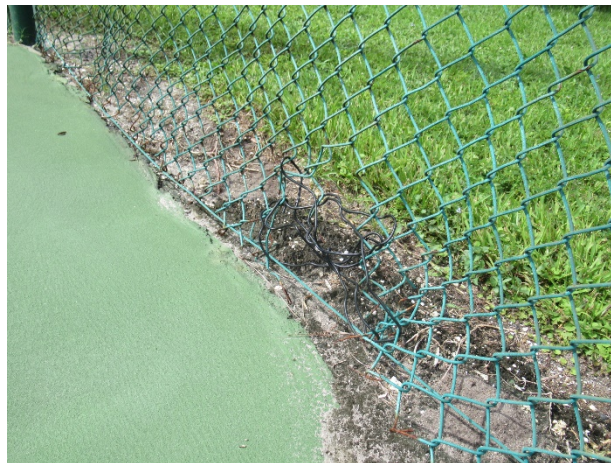
Tennis court fence with past repair evident

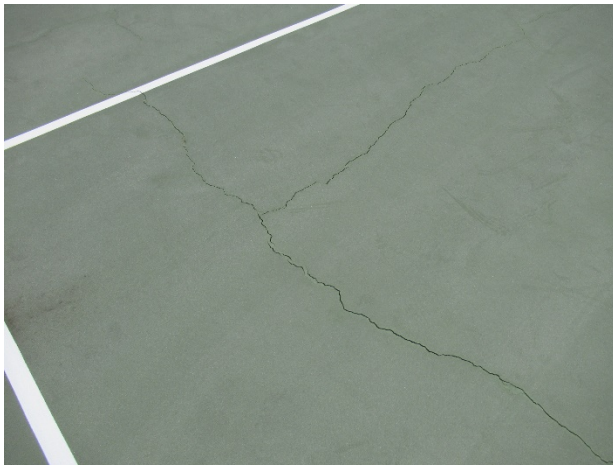
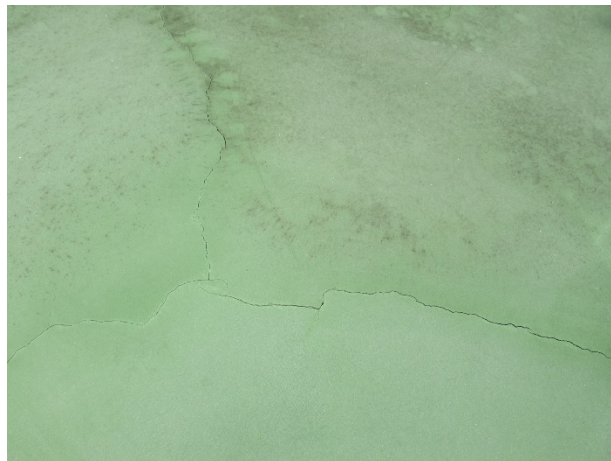
Condition: Good to fair overall with surface cracks evident

Tennis court surface with cracks

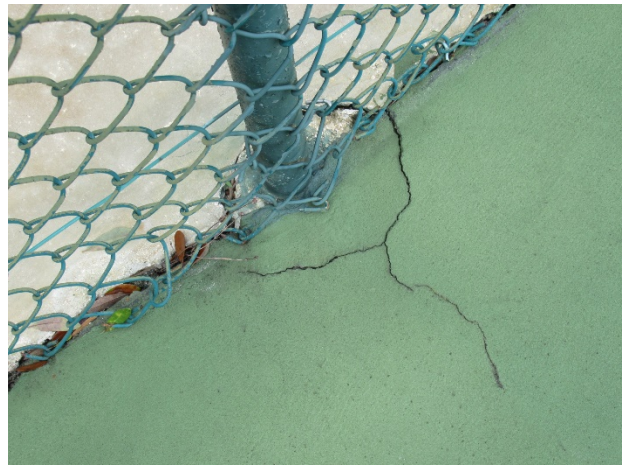
Tennis court surface with cracks around fence post

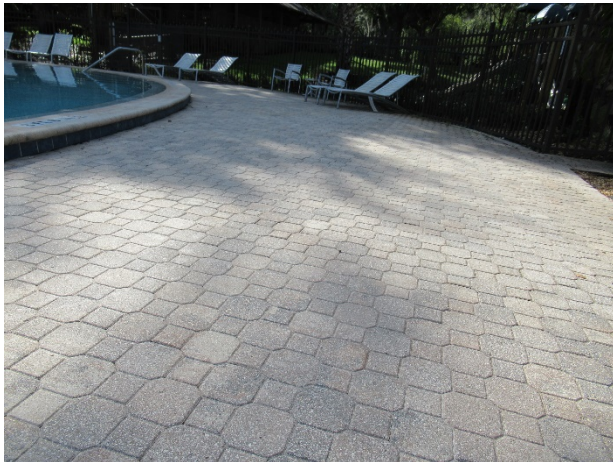
Pool deck overview

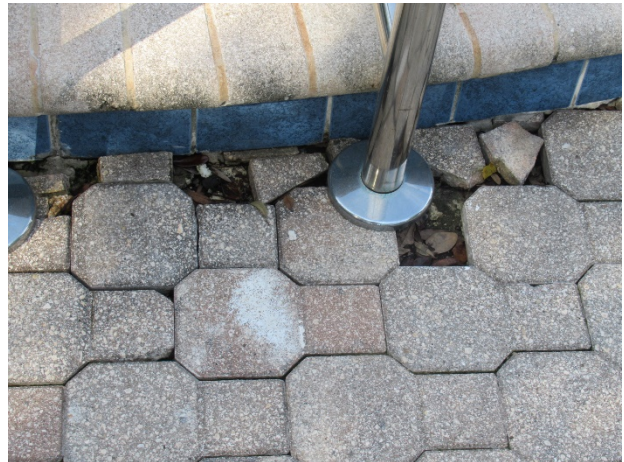
Condition: Good to fair overall condition with isolated damaged and displaced pavers evident

Pool deck with damaged and displaced pavers

Expenditure Detail Notes: Expenditure timing and costs are depicted in the **Reserve Expenditures** table in Section 3. We recommend the Association fund interim inspections, partial replacements and repairs through the operating budget.

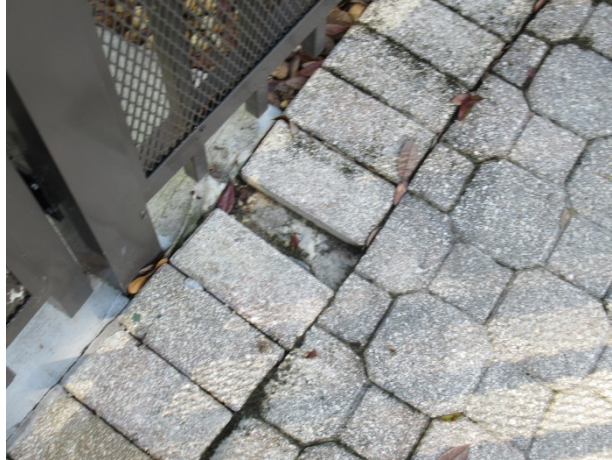
Pool deck with displaced pavers

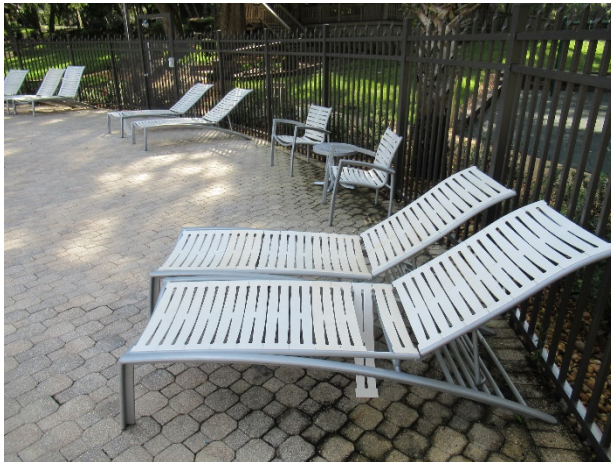
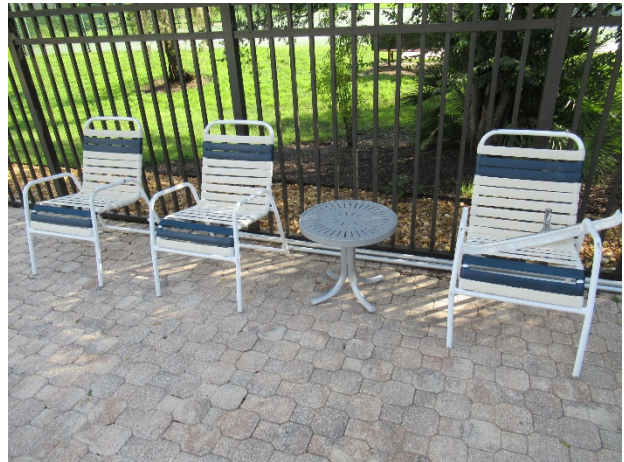
Condition: Fair overall with isolated damaged strapping

Pool furniture overview

Expenditure Detail Notes: Expenditure timing and costs are depicted in the **Reserve Expenditures** table in Section 3. We recommend interim re-strapping, refinishing, cushion replacements, reupholstering and other repairs to the furniture as normal maintenance to maximize its useful life.

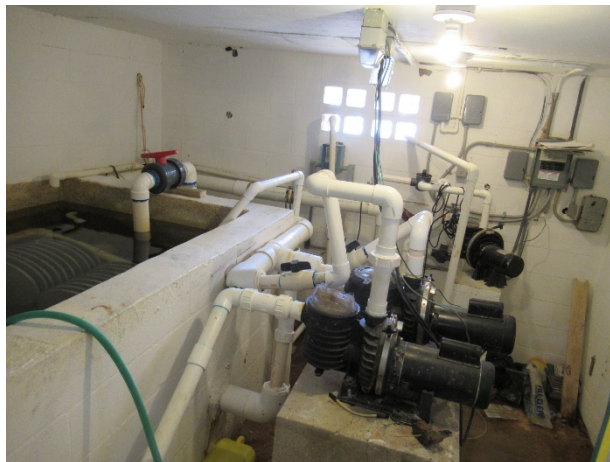
Condition: The mechanical equipment house was flooded at the time of the inspection due to a minor part failure. Management informs us that this minor repair will be funded through the operating budget. Otherwise the condition is reported satisfactory.

Mechanical equipment overview

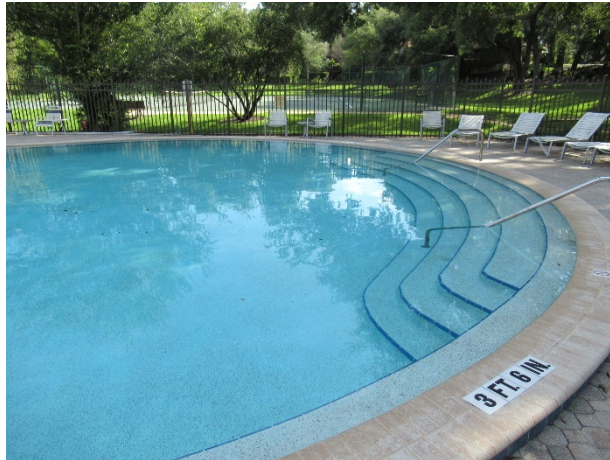
Conditions: Visually appears in good condition. The concrete floor and walls have a plaster finish. This finish makes it difficult to thoroughly inspect the concrete structure during a noninvasive visual inspection.

Pool structure
