Property Site Elements

Asphalt Pavement, Repaving

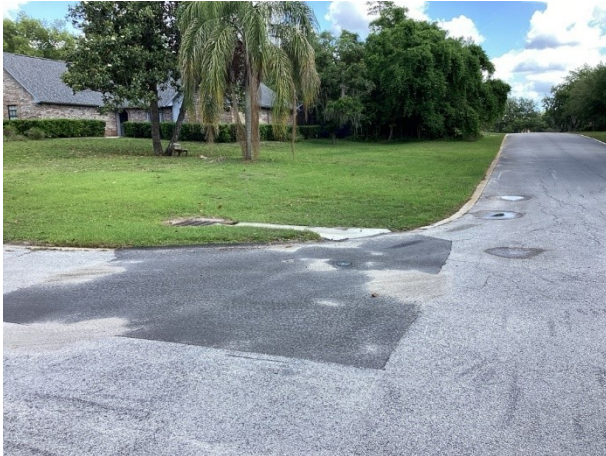
Pavement overview near English Brick Trail

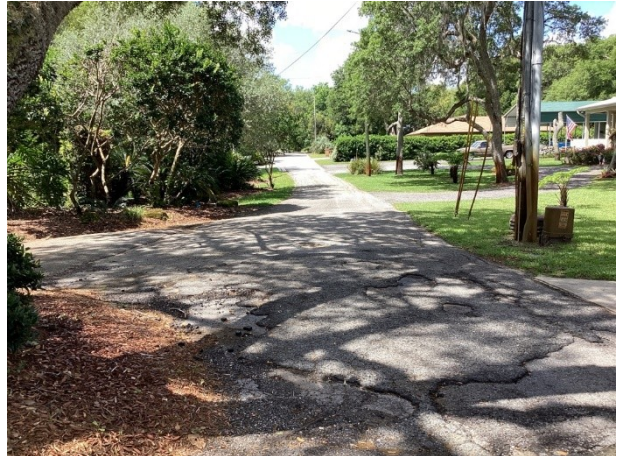
Extensive deterioration at Trail by the Lake

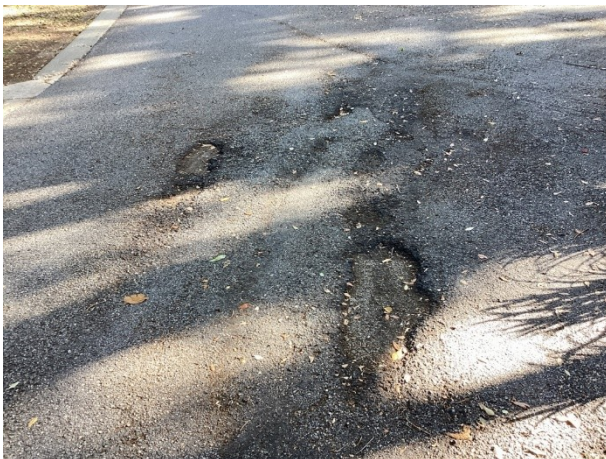
Pothole formation near 10 Autumnwood Trail

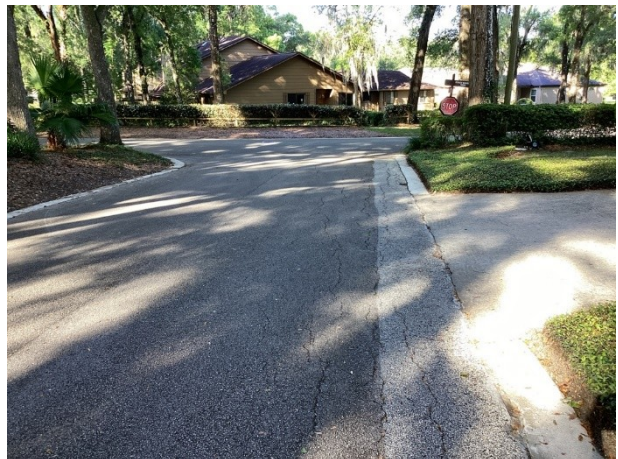
Cracks along Lone Tree Trail

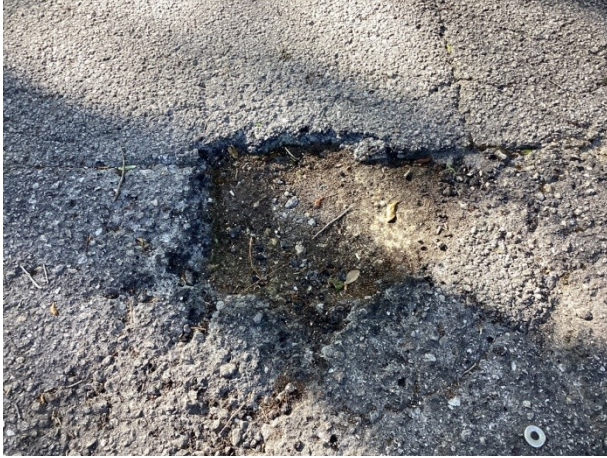
Pothole formation near 810 Shady Branch Trail

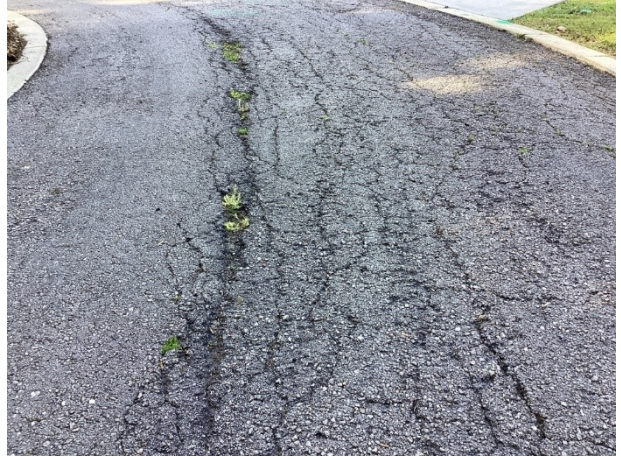
Extensive deterioration near 807 Shady Branch Trail

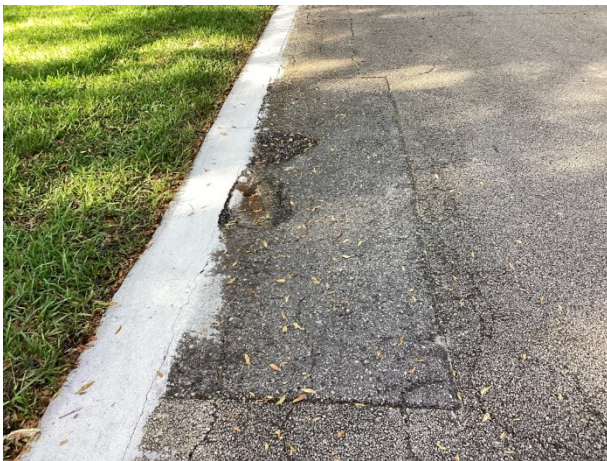
Deterioration at previous patch repairs

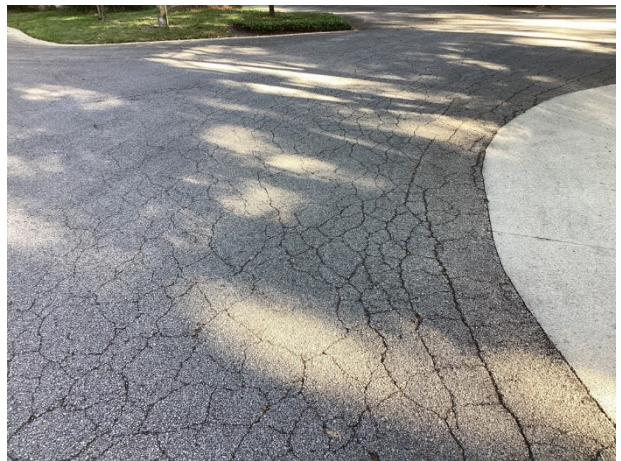
Extensive cracks near clubhouse at Shady Branch Trail

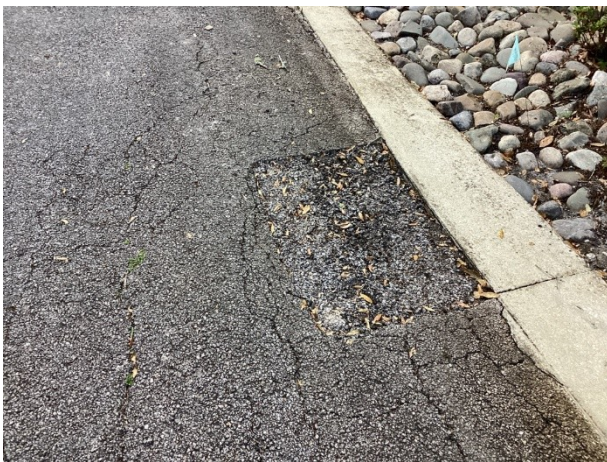
Isolated patch near clubhouse

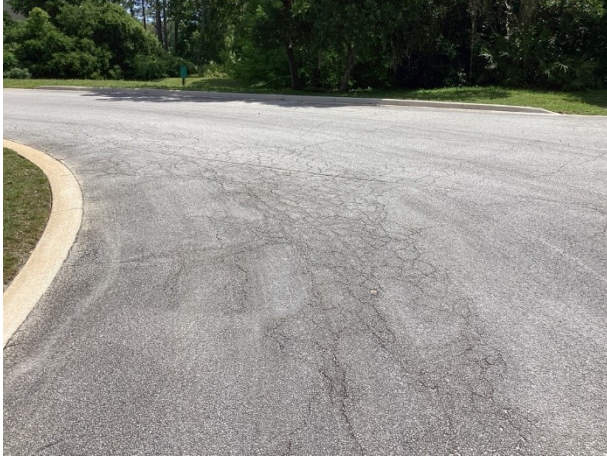
Extensive cracks at Black Willow Trail

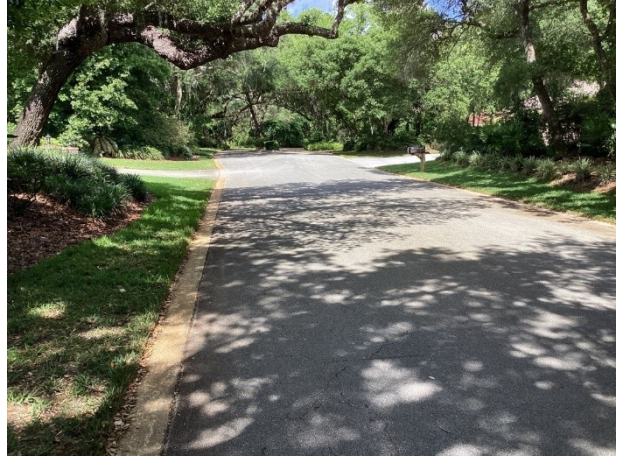
Pavement overview at Black Willow Trail

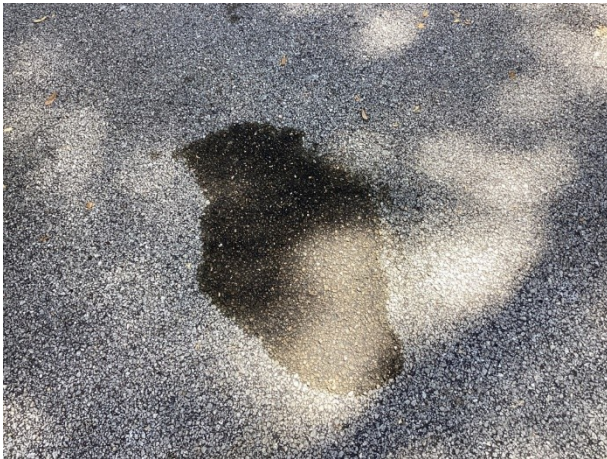
Vehicular stains at clubhouse parking area

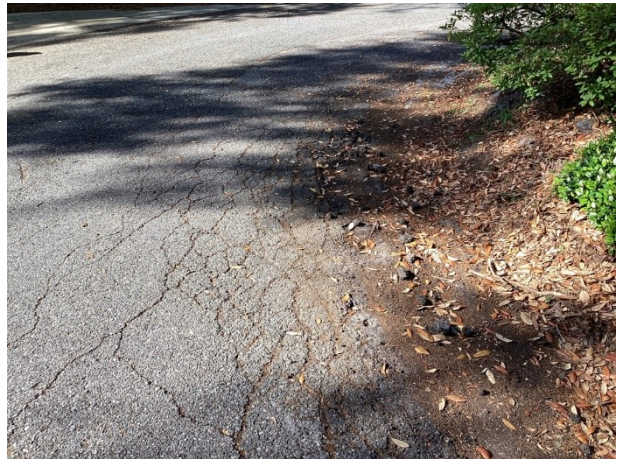
Washout along Black Bear Trail

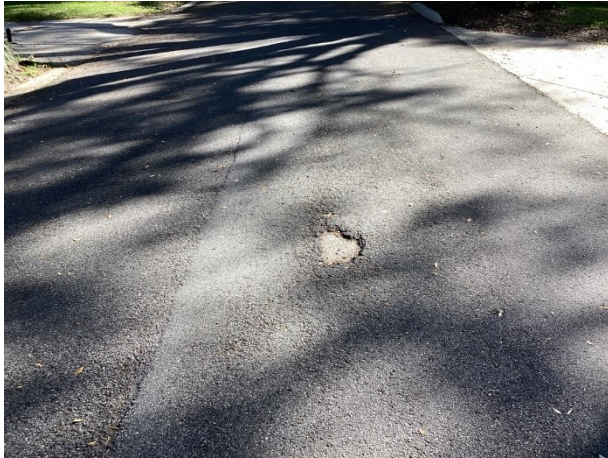
Top layer deterioration at Rollingwood Trail

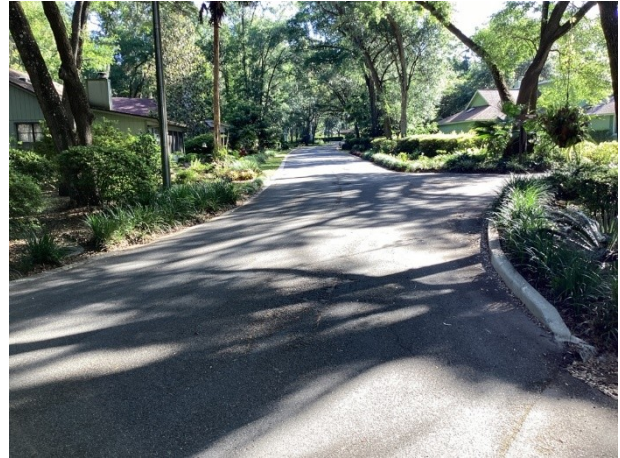
Pavement overview at Woodridge Trail

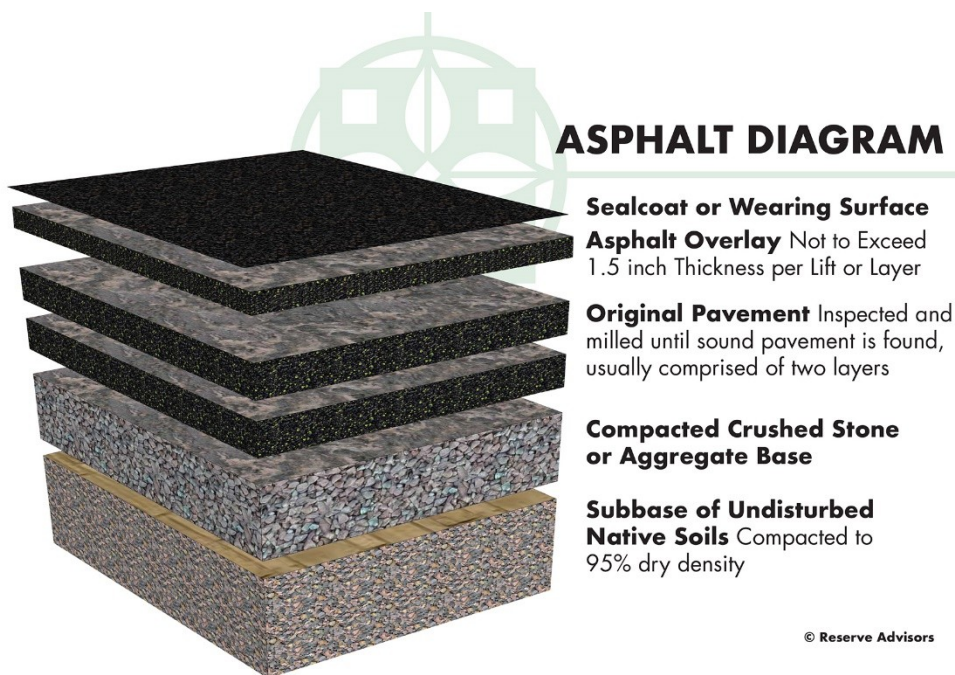
The initial installation of asphalt uses at least two lifts, or two separate applications of asphalt, over the base course. The first lift is the binder course. The second lift is the wearing course. The wearing course comprises a finer aggregate for a smoother more watertight finish. The following diagram depicts the typical components although it may not reflect the actual configuration at Trails West:

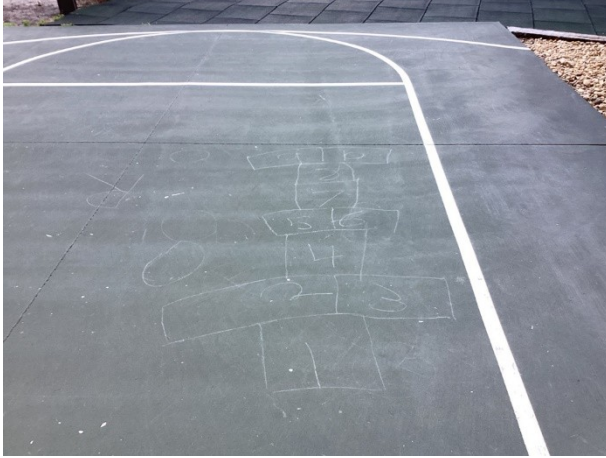
Basketball court overview

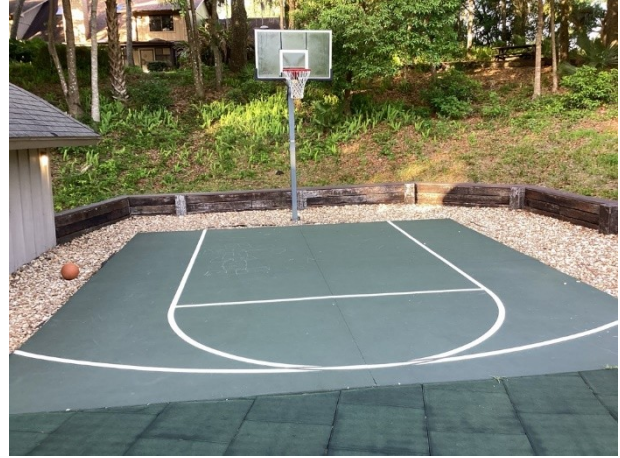
Basketball court overview

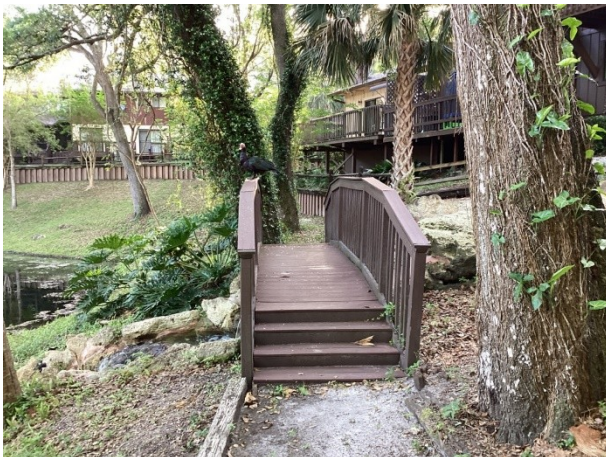
Condition: Good to fair overall

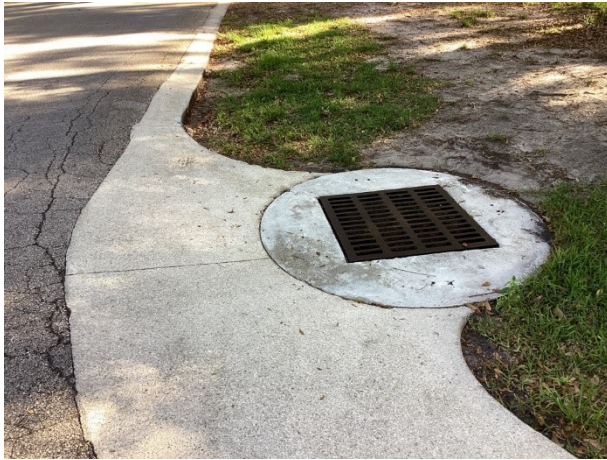
Condition: Good to fair overall, we note that the catch basin grate near the entrance to the clubhouse is severely corroded and should be replaced, funded by the operating budget.

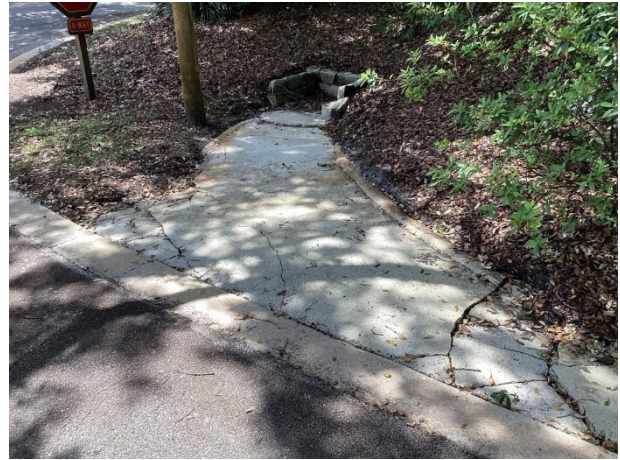
Concrete deterioration leading to catch basin

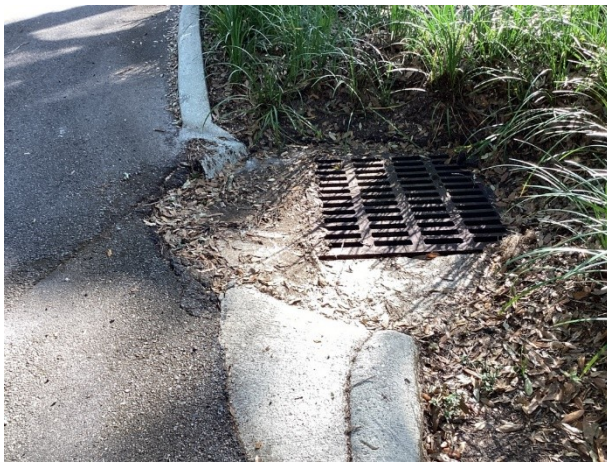
Debris accumulation at catch basin along Woodridge Trail

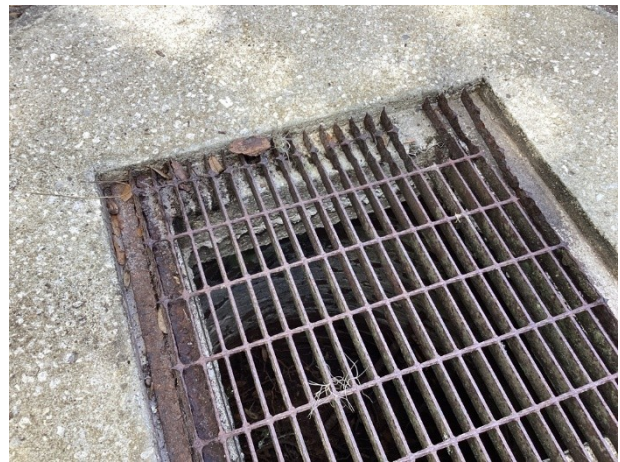
Extensive corrosion at catch basin grate at clubhouse

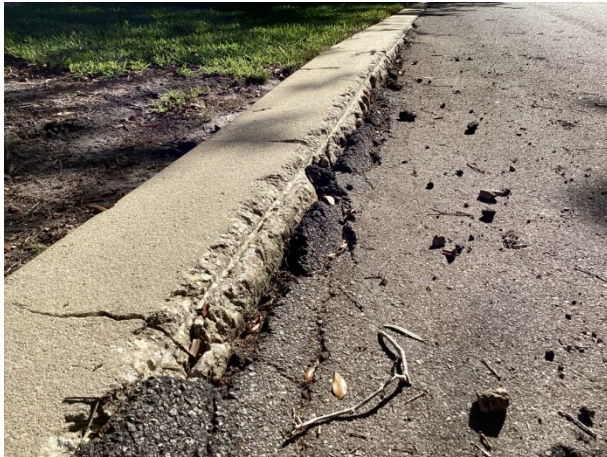
Curb deterioration at Wildwood Trail

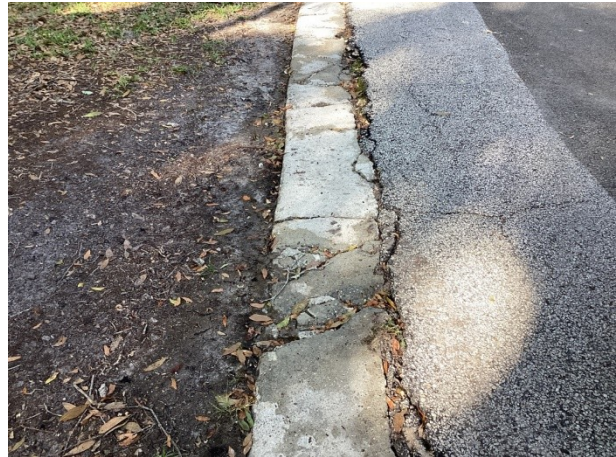
Gutter deterioration along Lone Tree Trail

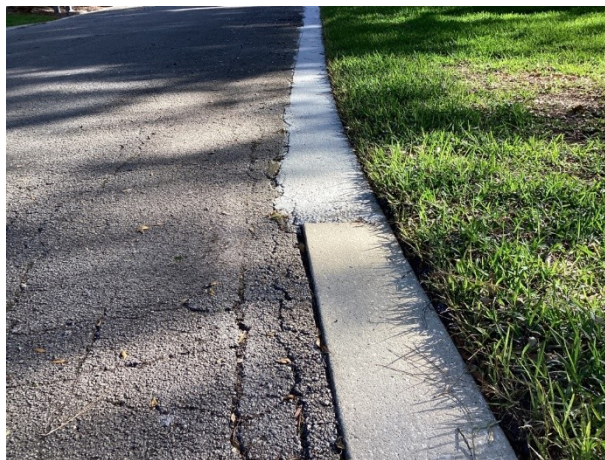
Gutter replacements evident

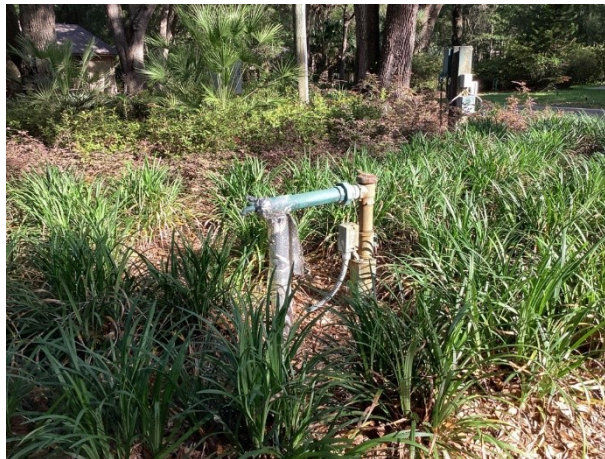
Irrigation equipment at Autumnwood Trail

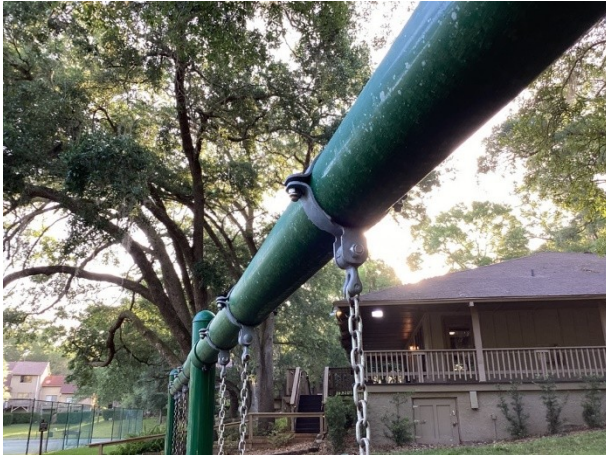
Organic growth at swings

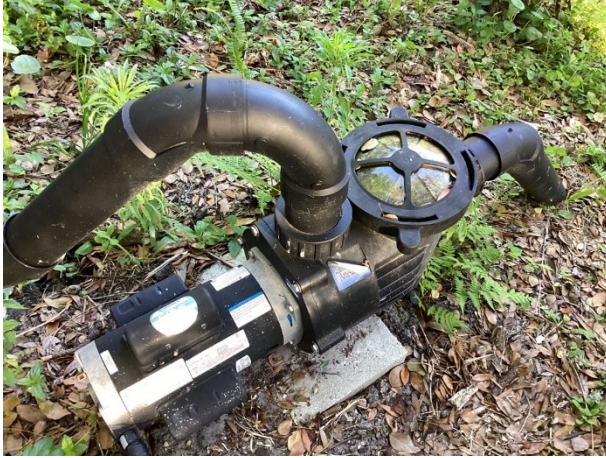
5-HP pond fountain aerator pump

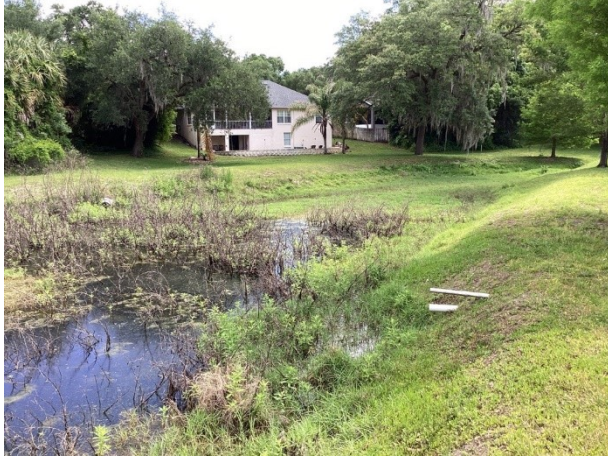
Extensive vegetation at pond north of playground

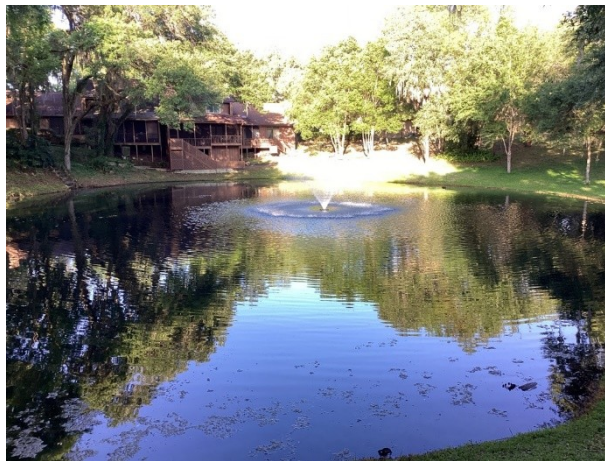
Extensive vegetation at pond north of playground

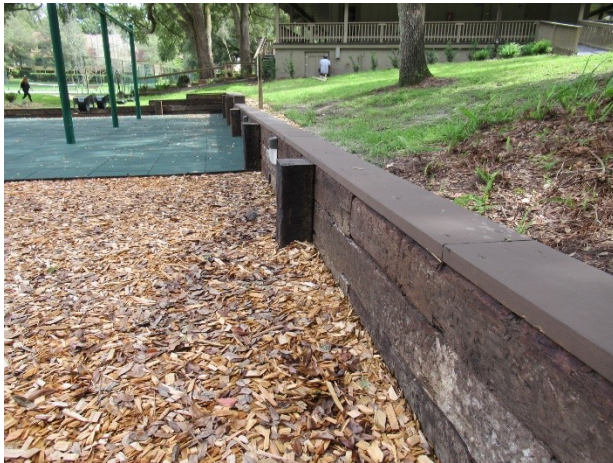
Playground retaining wall overview

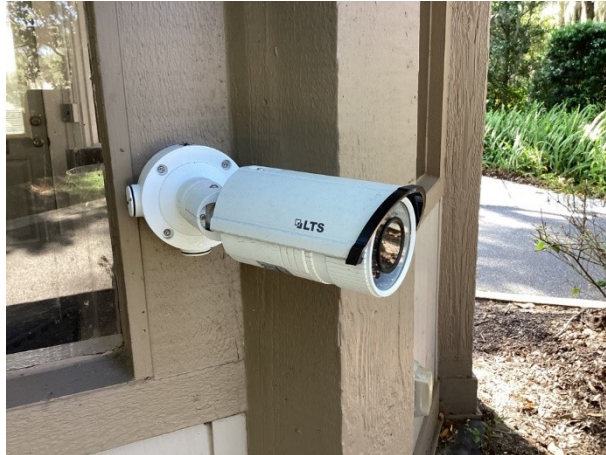
Security system camera

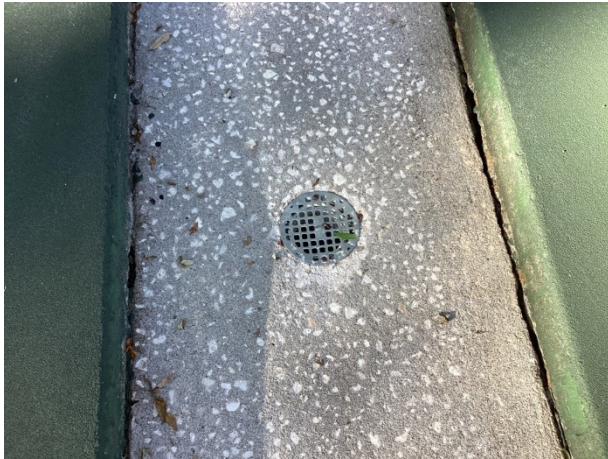
Drainage at shuffleboard court

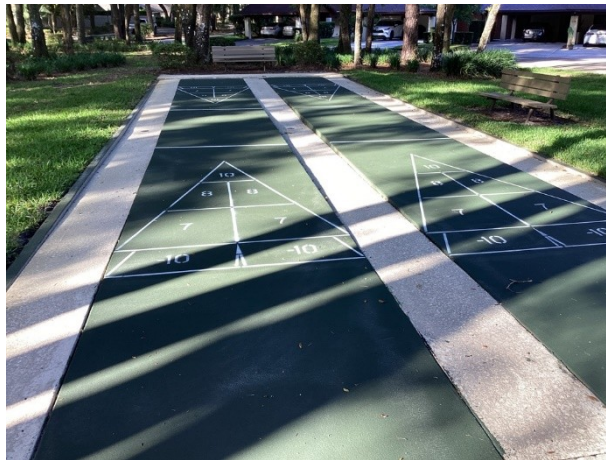
Exposed concrete reinforcement

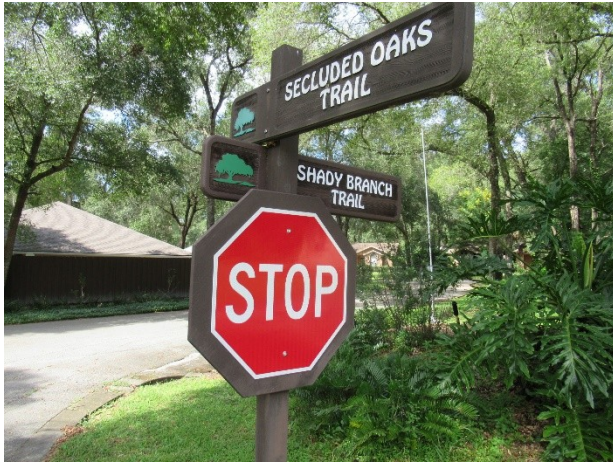
Street and traffic sign overview

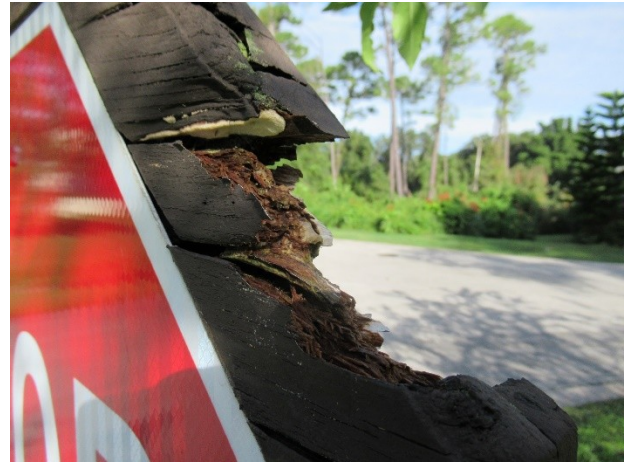
Street and traffic sign with wood rot

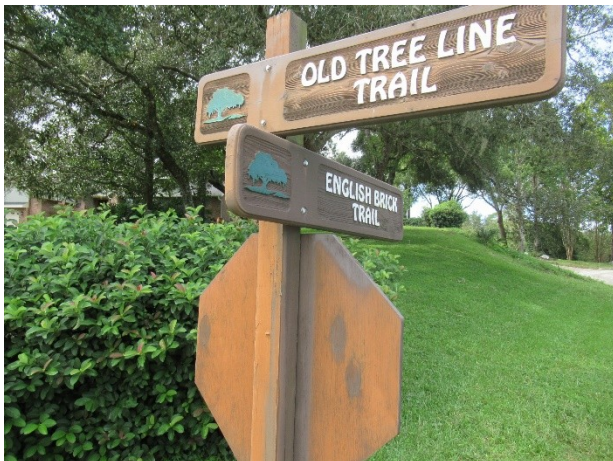
Street and traffic sign with finish deterioration

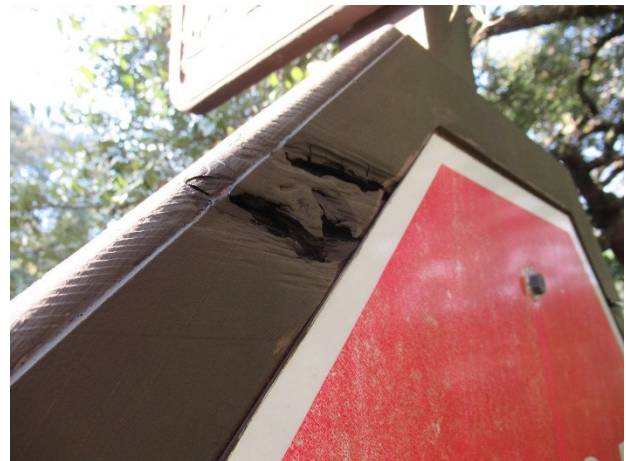
Street and traffic sign with wood rot and finish deterioration

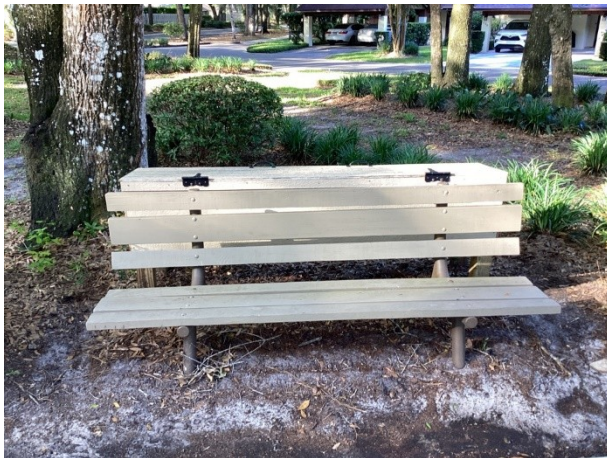
Bench and shuffleboard storage

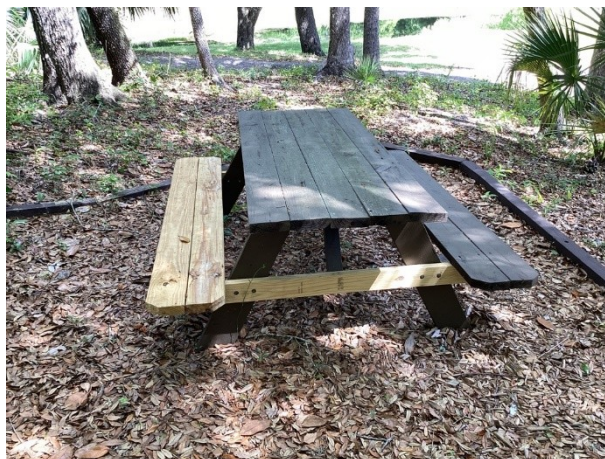
Repairs to picnic tables evident

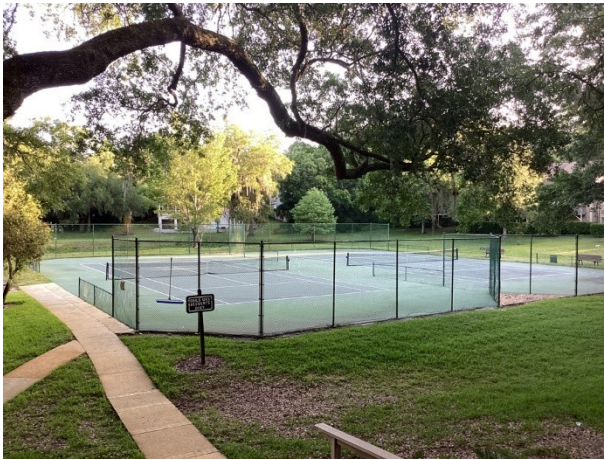
Tennis court overview

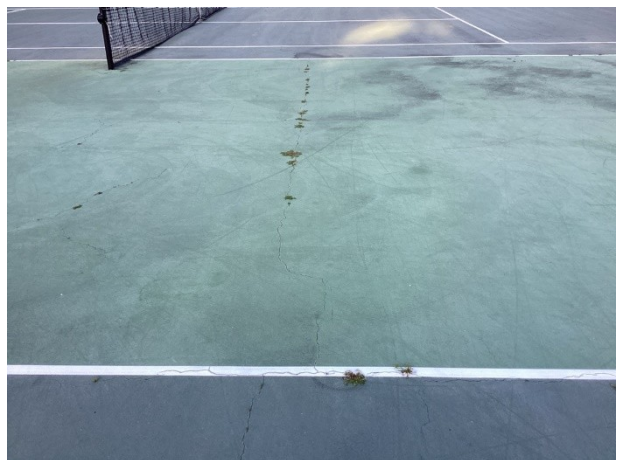
Surface cracks with vegetation

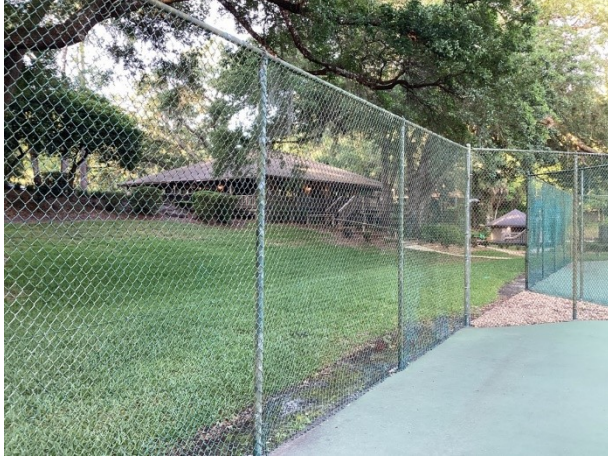
Condition: Fair overall with warped webbing and finish deterioration evident.

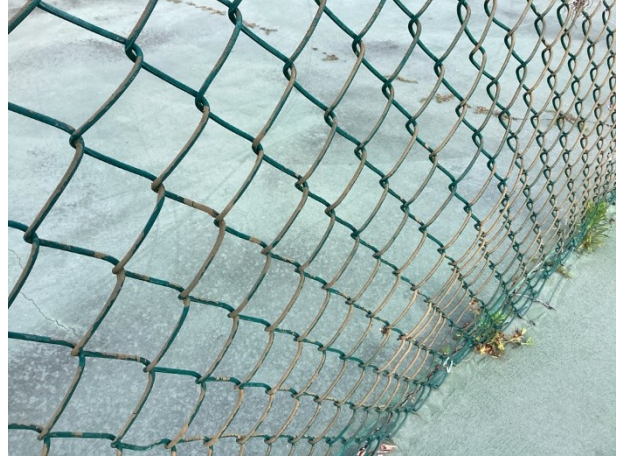
Fence warped webbing with finish deterioration

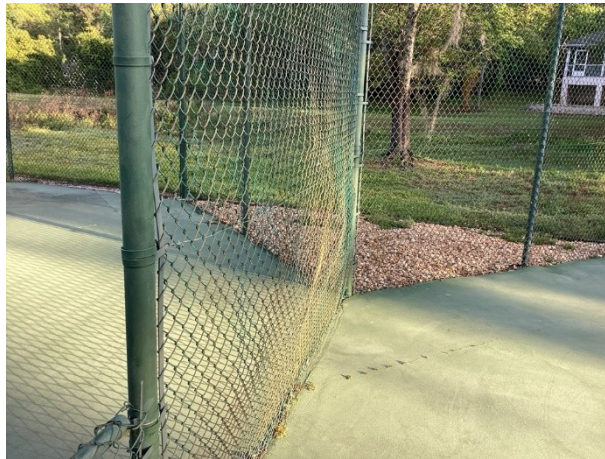
Fence warped webbing

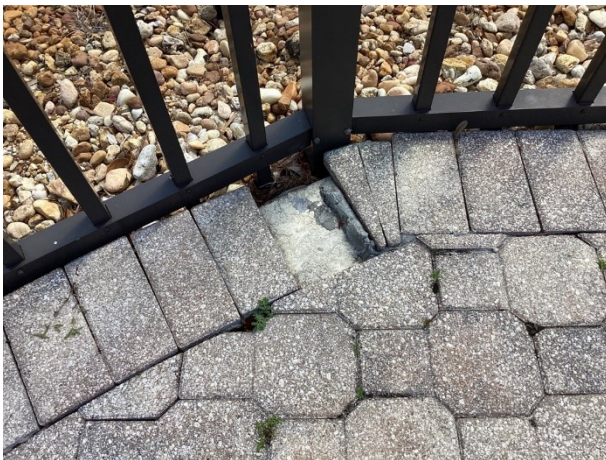
Condition: Good to fair overall condition with isolated damaged and displaced pavers evident. We note stains and vegetative growth as well.

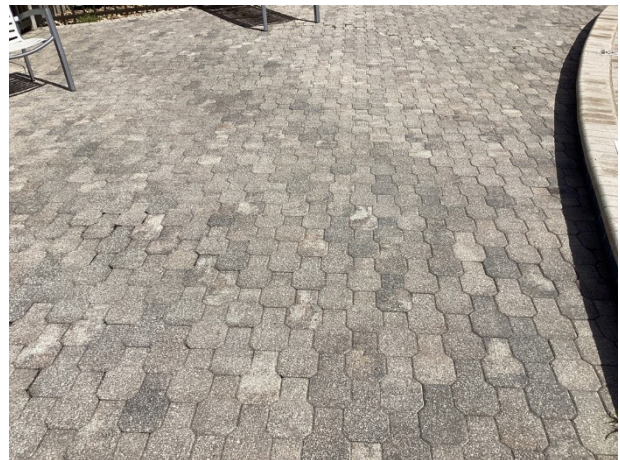
Paver pool deck overview

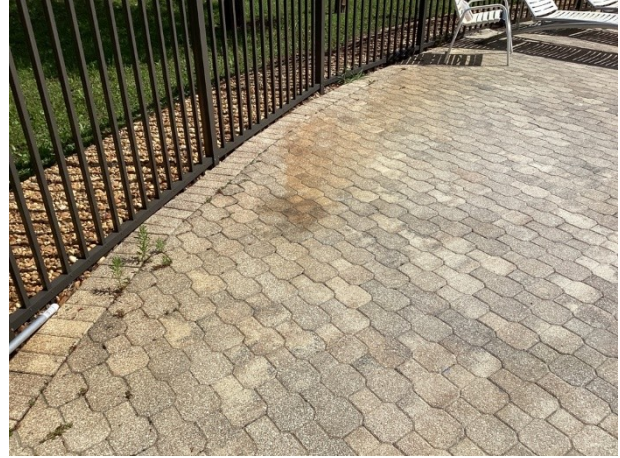
Weathered and stained pavers

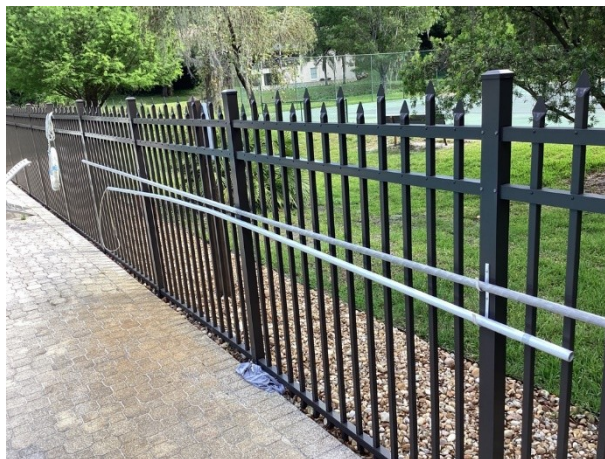
Condition: Good overall condition

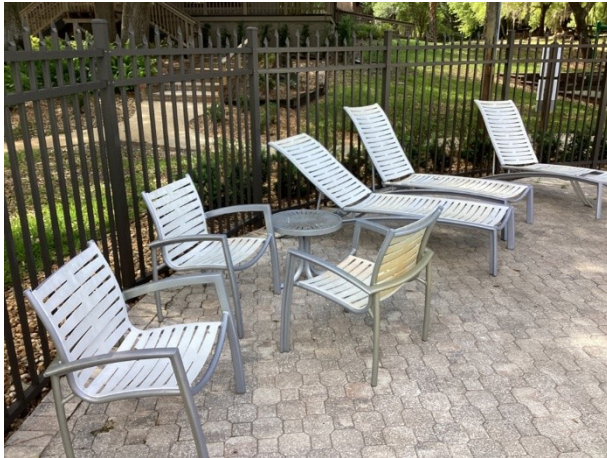
Pool furniture overview

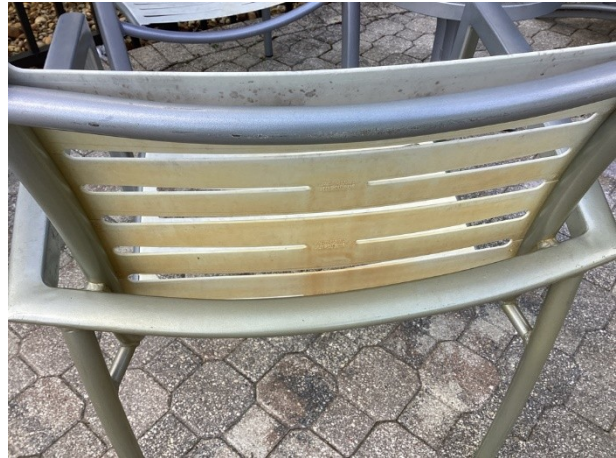
Stained pool furniture

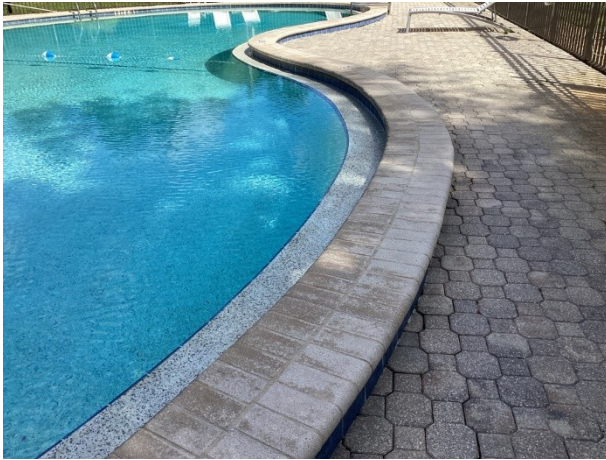
Condition: Good overall

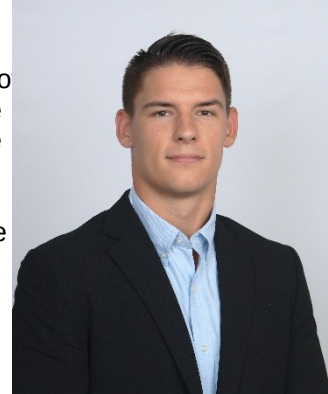
The following is a partial list of clients served by Brandon Bloomer demonstrating his breadth of experiential knowledge of community associations in construction and related buildings systems.
